“ The Himalayan Hazard: Post-Event Assessment of Thame's GLOF ”

Thame GLOF Field-Based Assessment

Keshab Sharma, PhD
BGC Engineering Inc., Canada

December 13, 2024

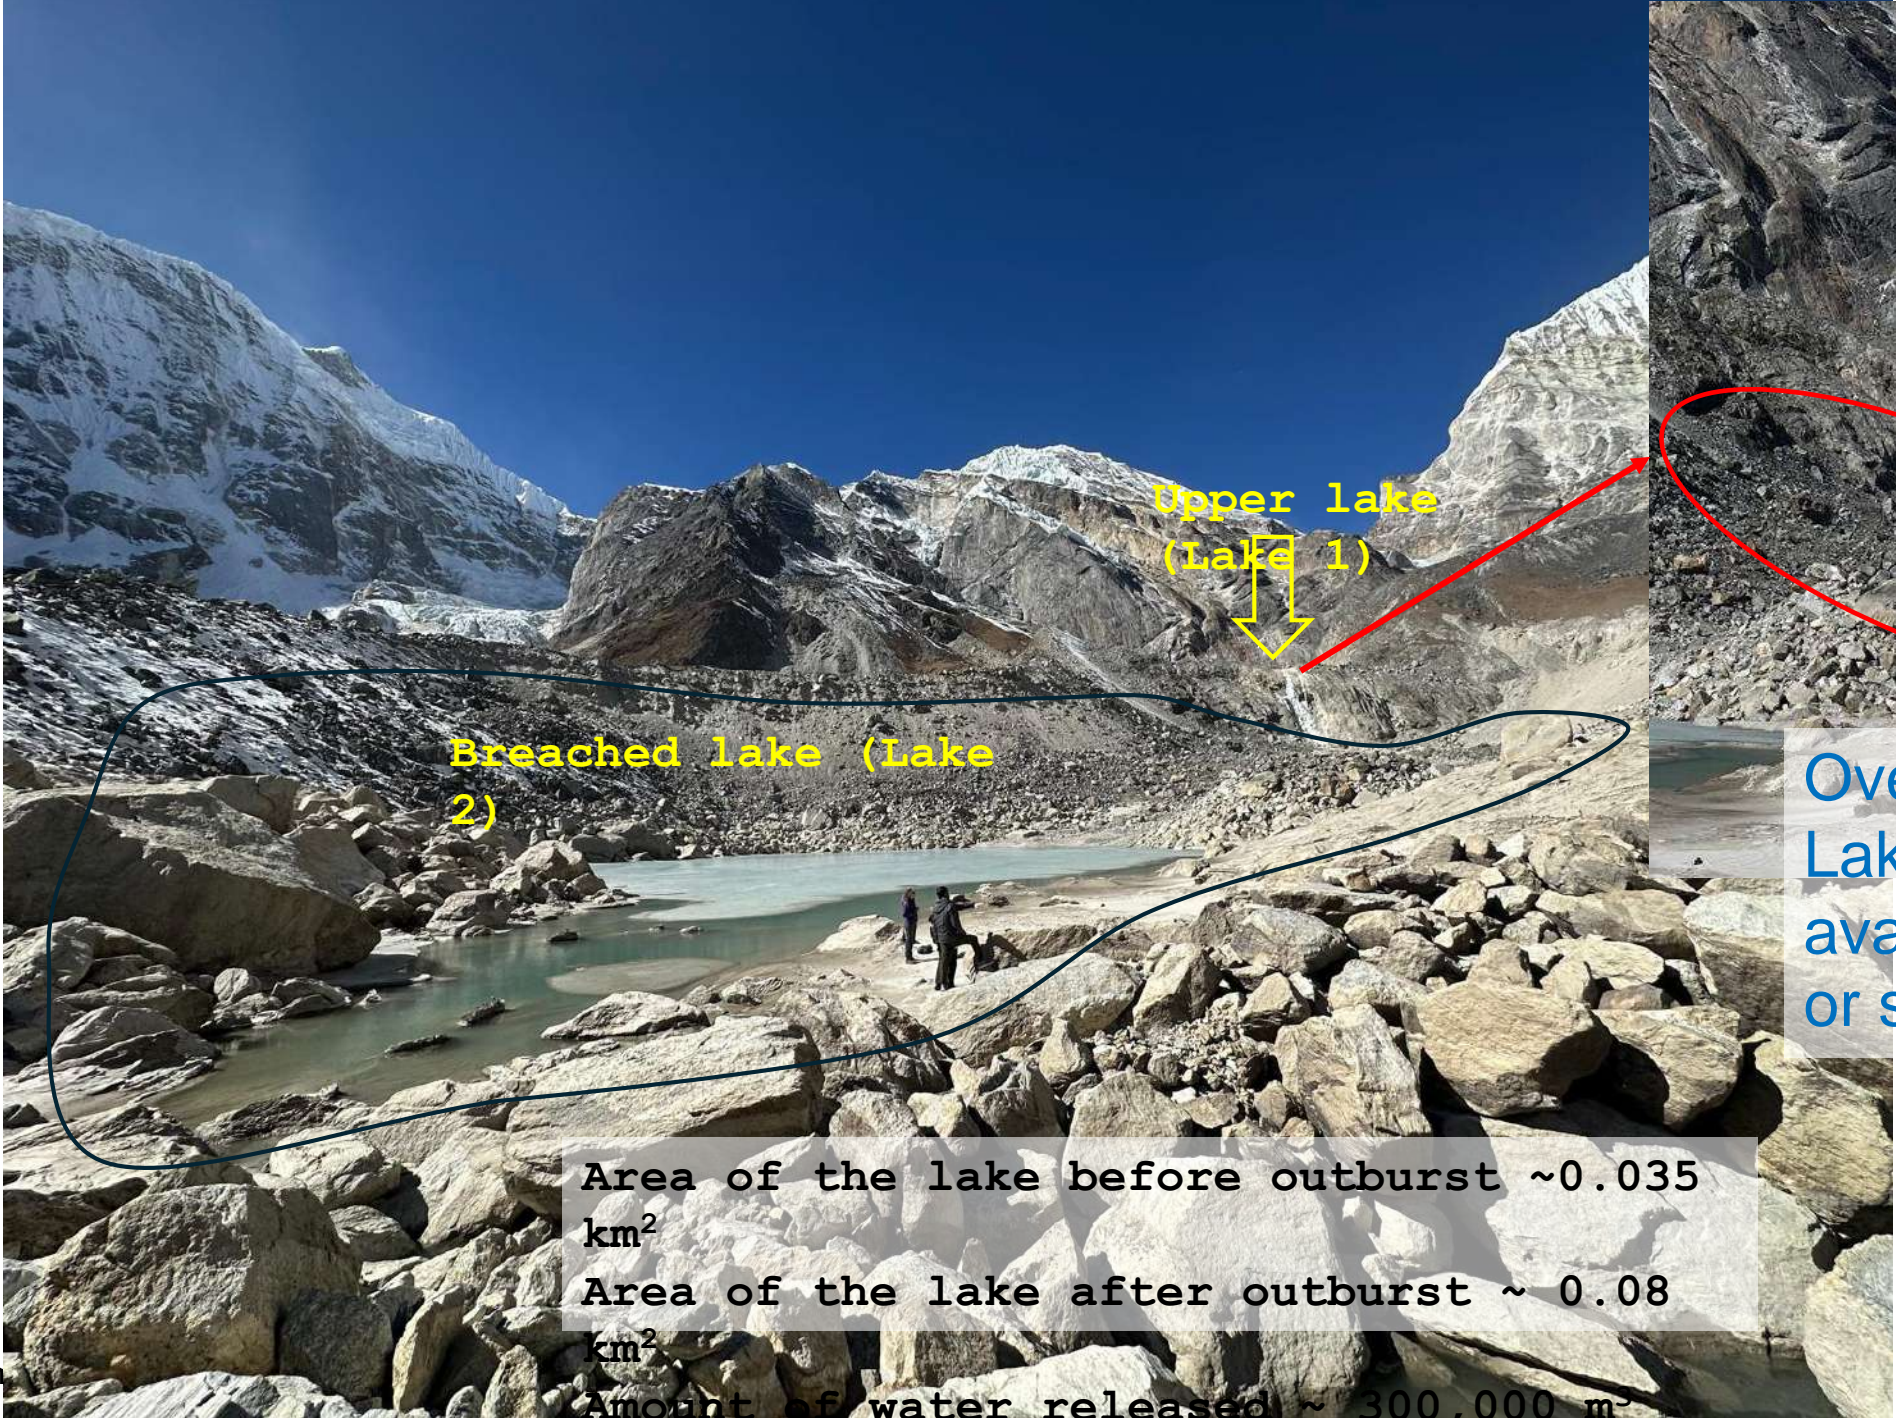
Upper lake
(Lake 1)

Breached lake (Lake
2)

Area of the lake before outburst ~ 0.035
 km^2

Area of the lake after outburst ~ 0.08
 km^2

Amount of water released $\sim 300,000 \text{ m}^3$

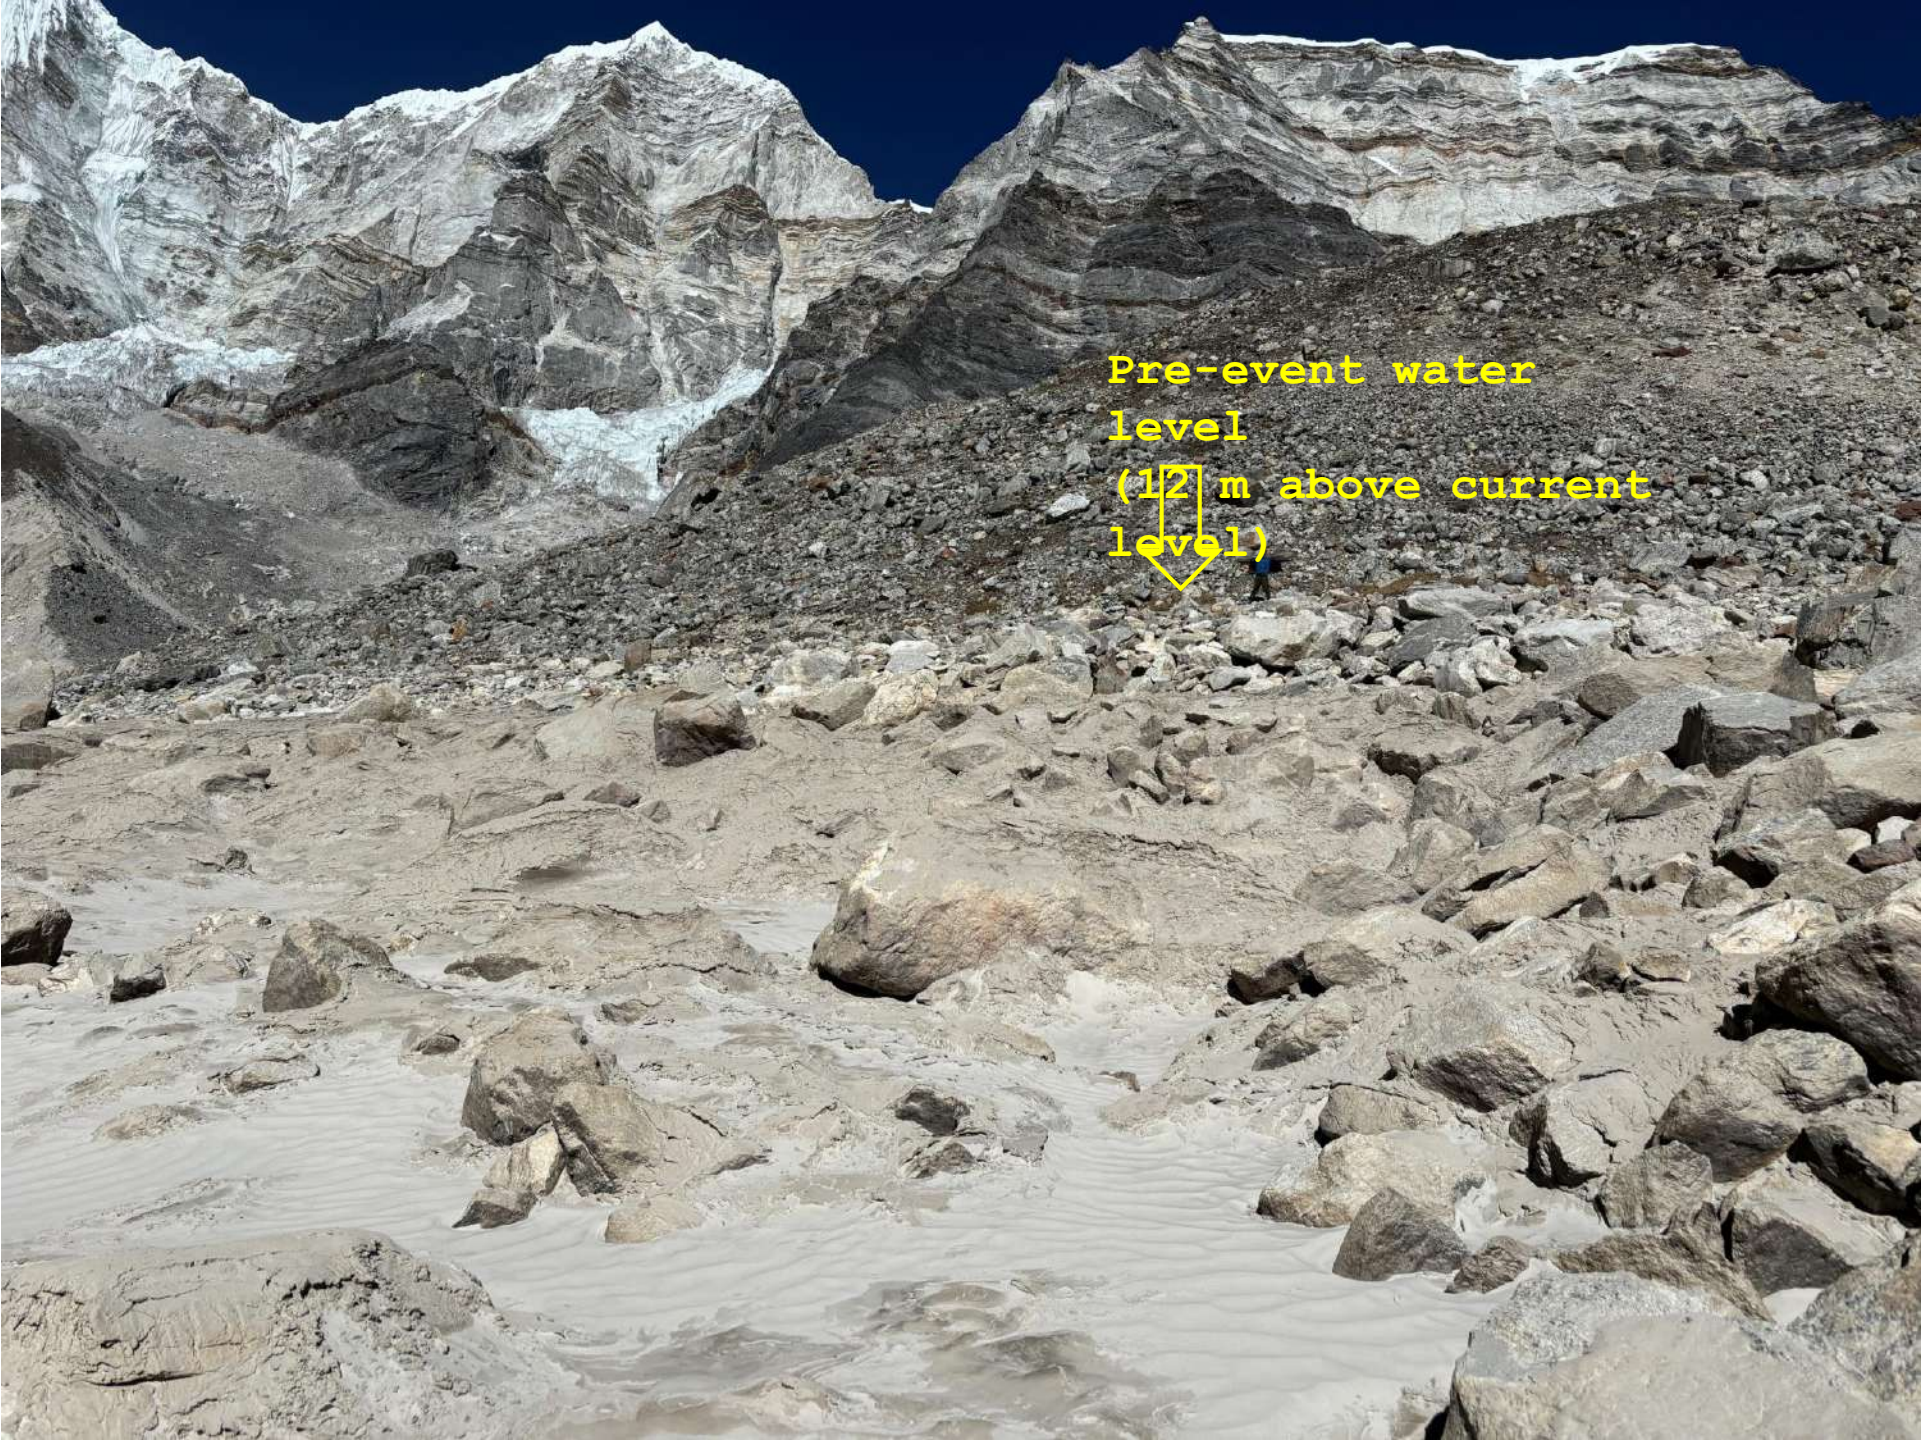
Pre-event water
level
(12 m above current
level)

Figure 5: Surface area of the lake before and after the outburst (the darker yellow area indicates the current surface area after the outburst, base map: Google earth pro December 2017).

Figure 6: Comparison of the surface area of Lake 2 before and after the outburst.

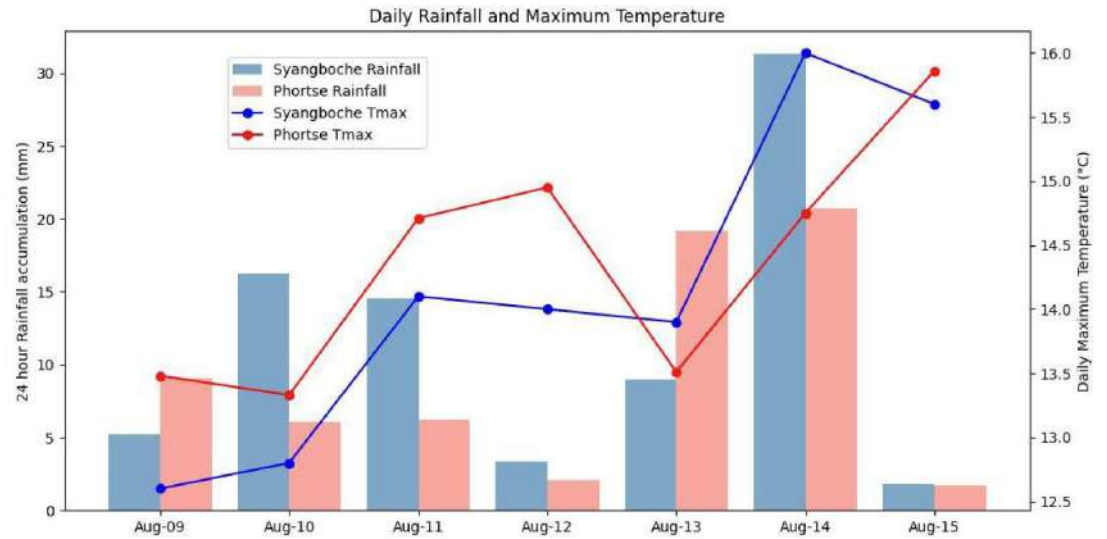
Figure 4: Rainfall and maximum temperature recorded at Syangboche and Phortse between August 9 and 15

- Significant amount of rainfall in the previous week
- Increase in temperature
- Glacier/ice melt or avalanches may have caused the upper lake to overflow into the lower leading to the outburst of the lower lake

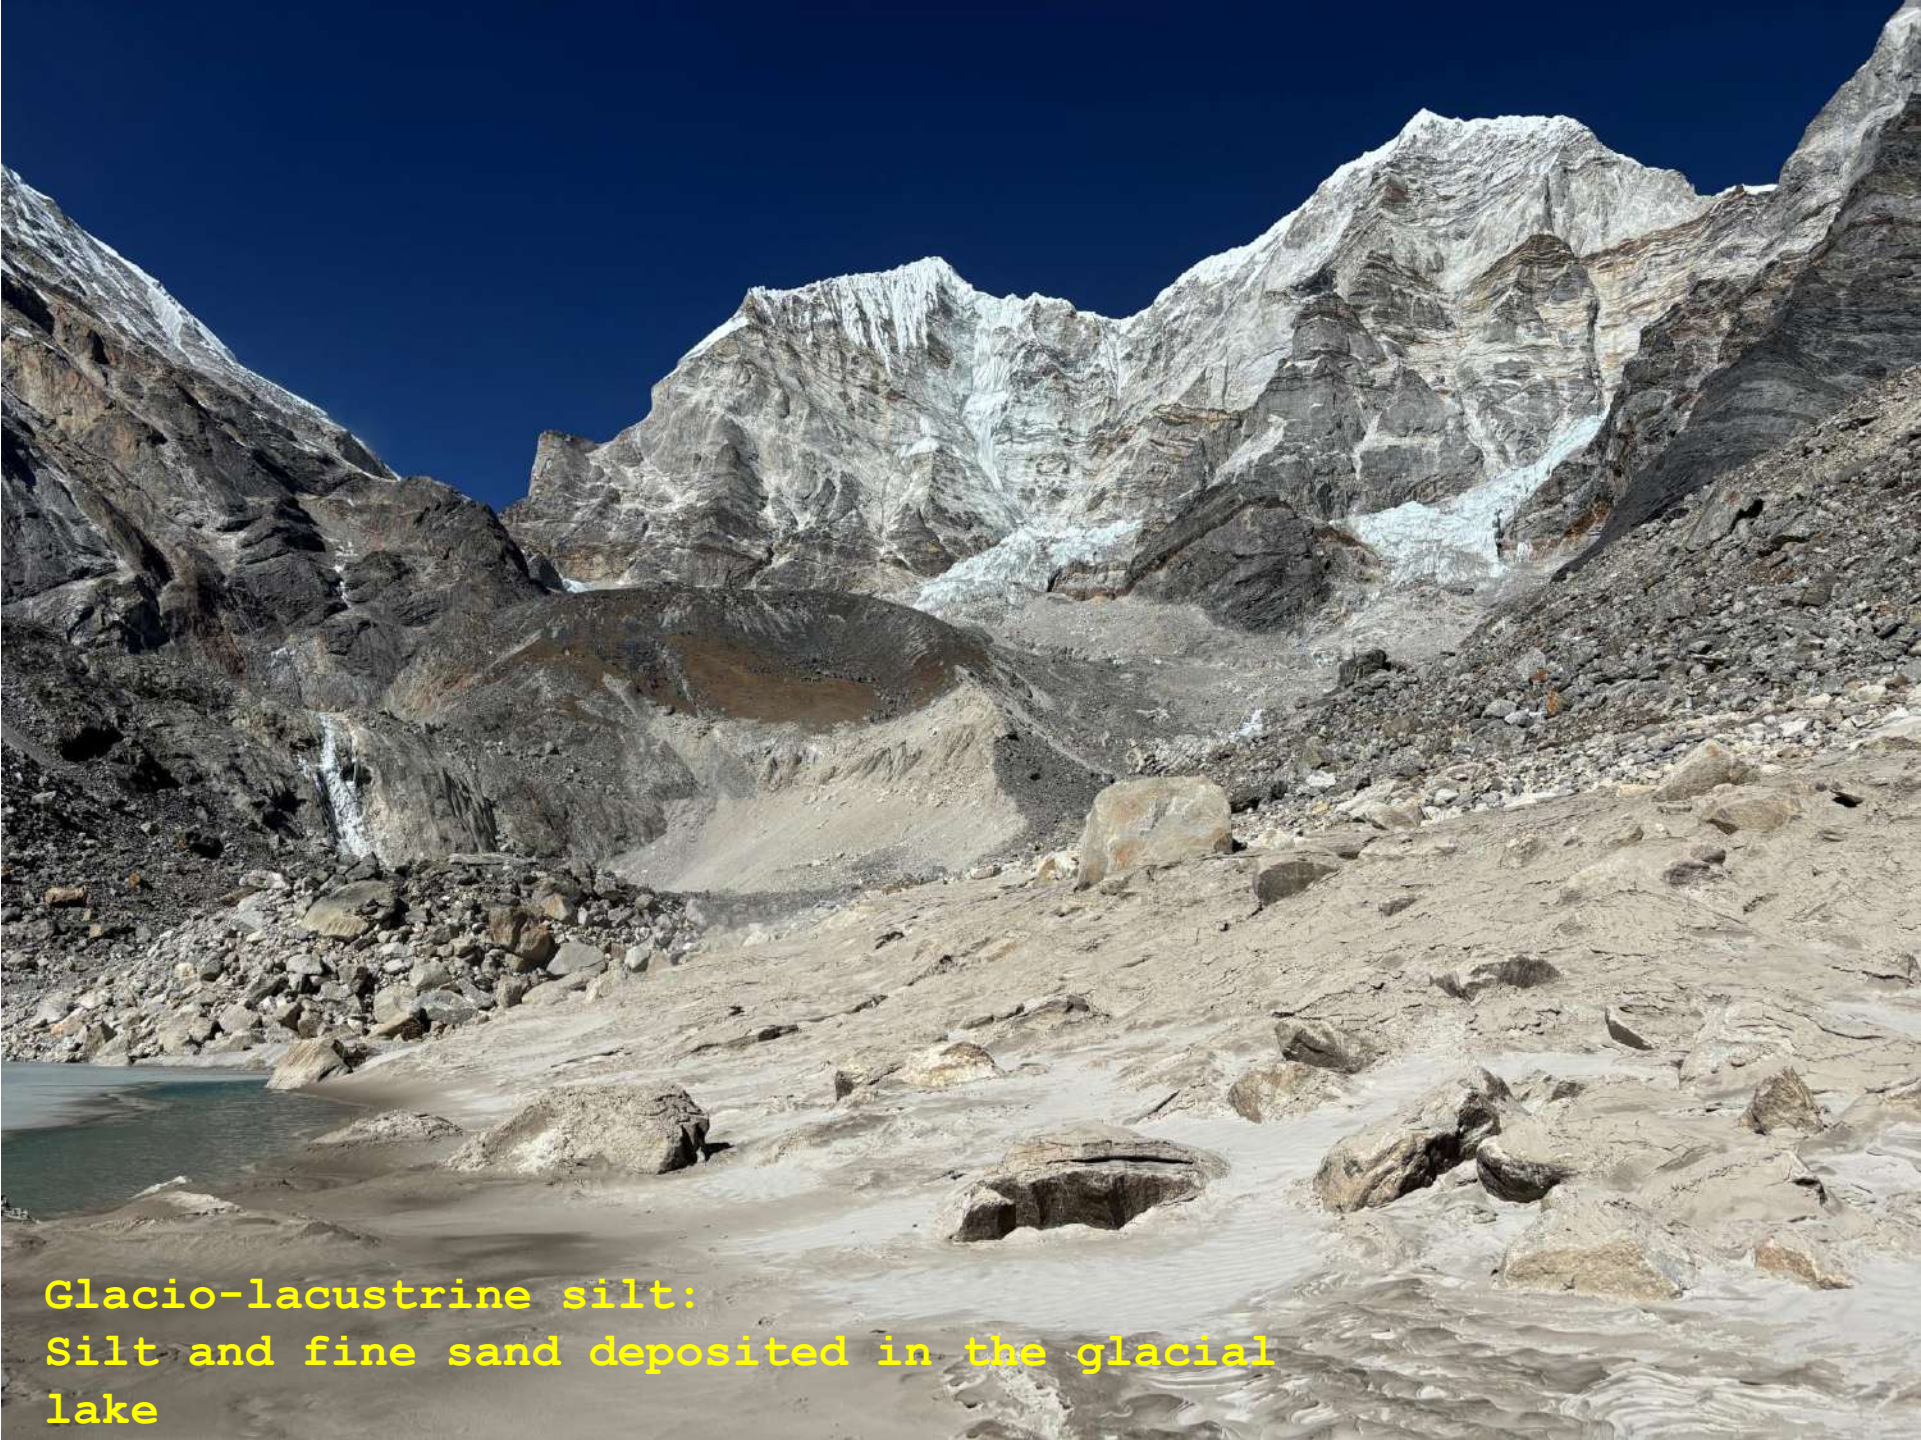
Glacio-lacustrine silt:
Silt and fine sand deposited in the glacial
lake

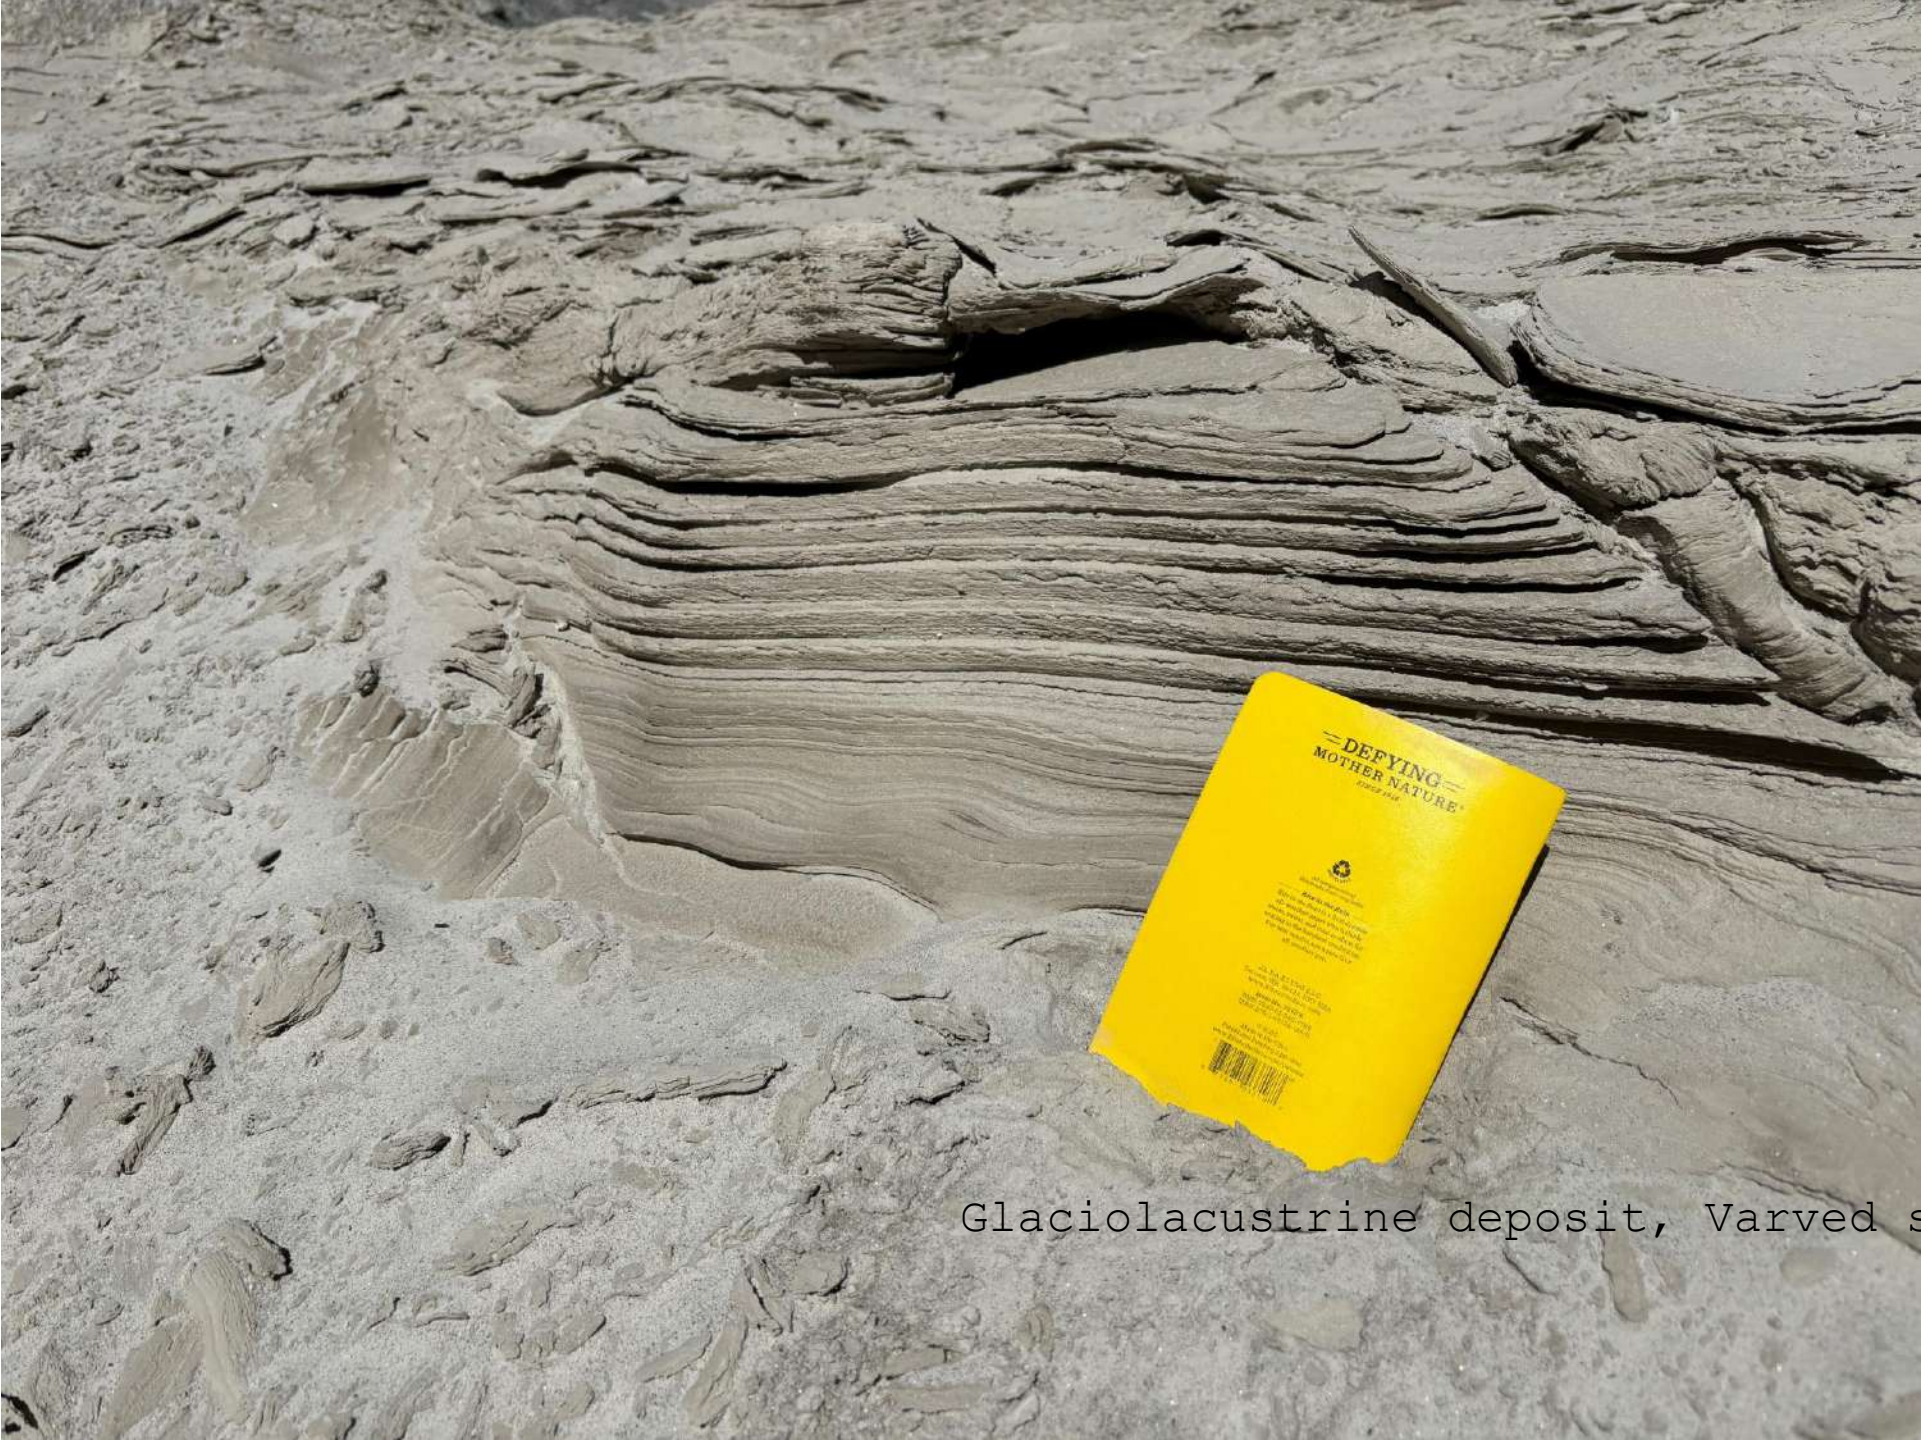
Glaciolacustrine deposit, Varved structure

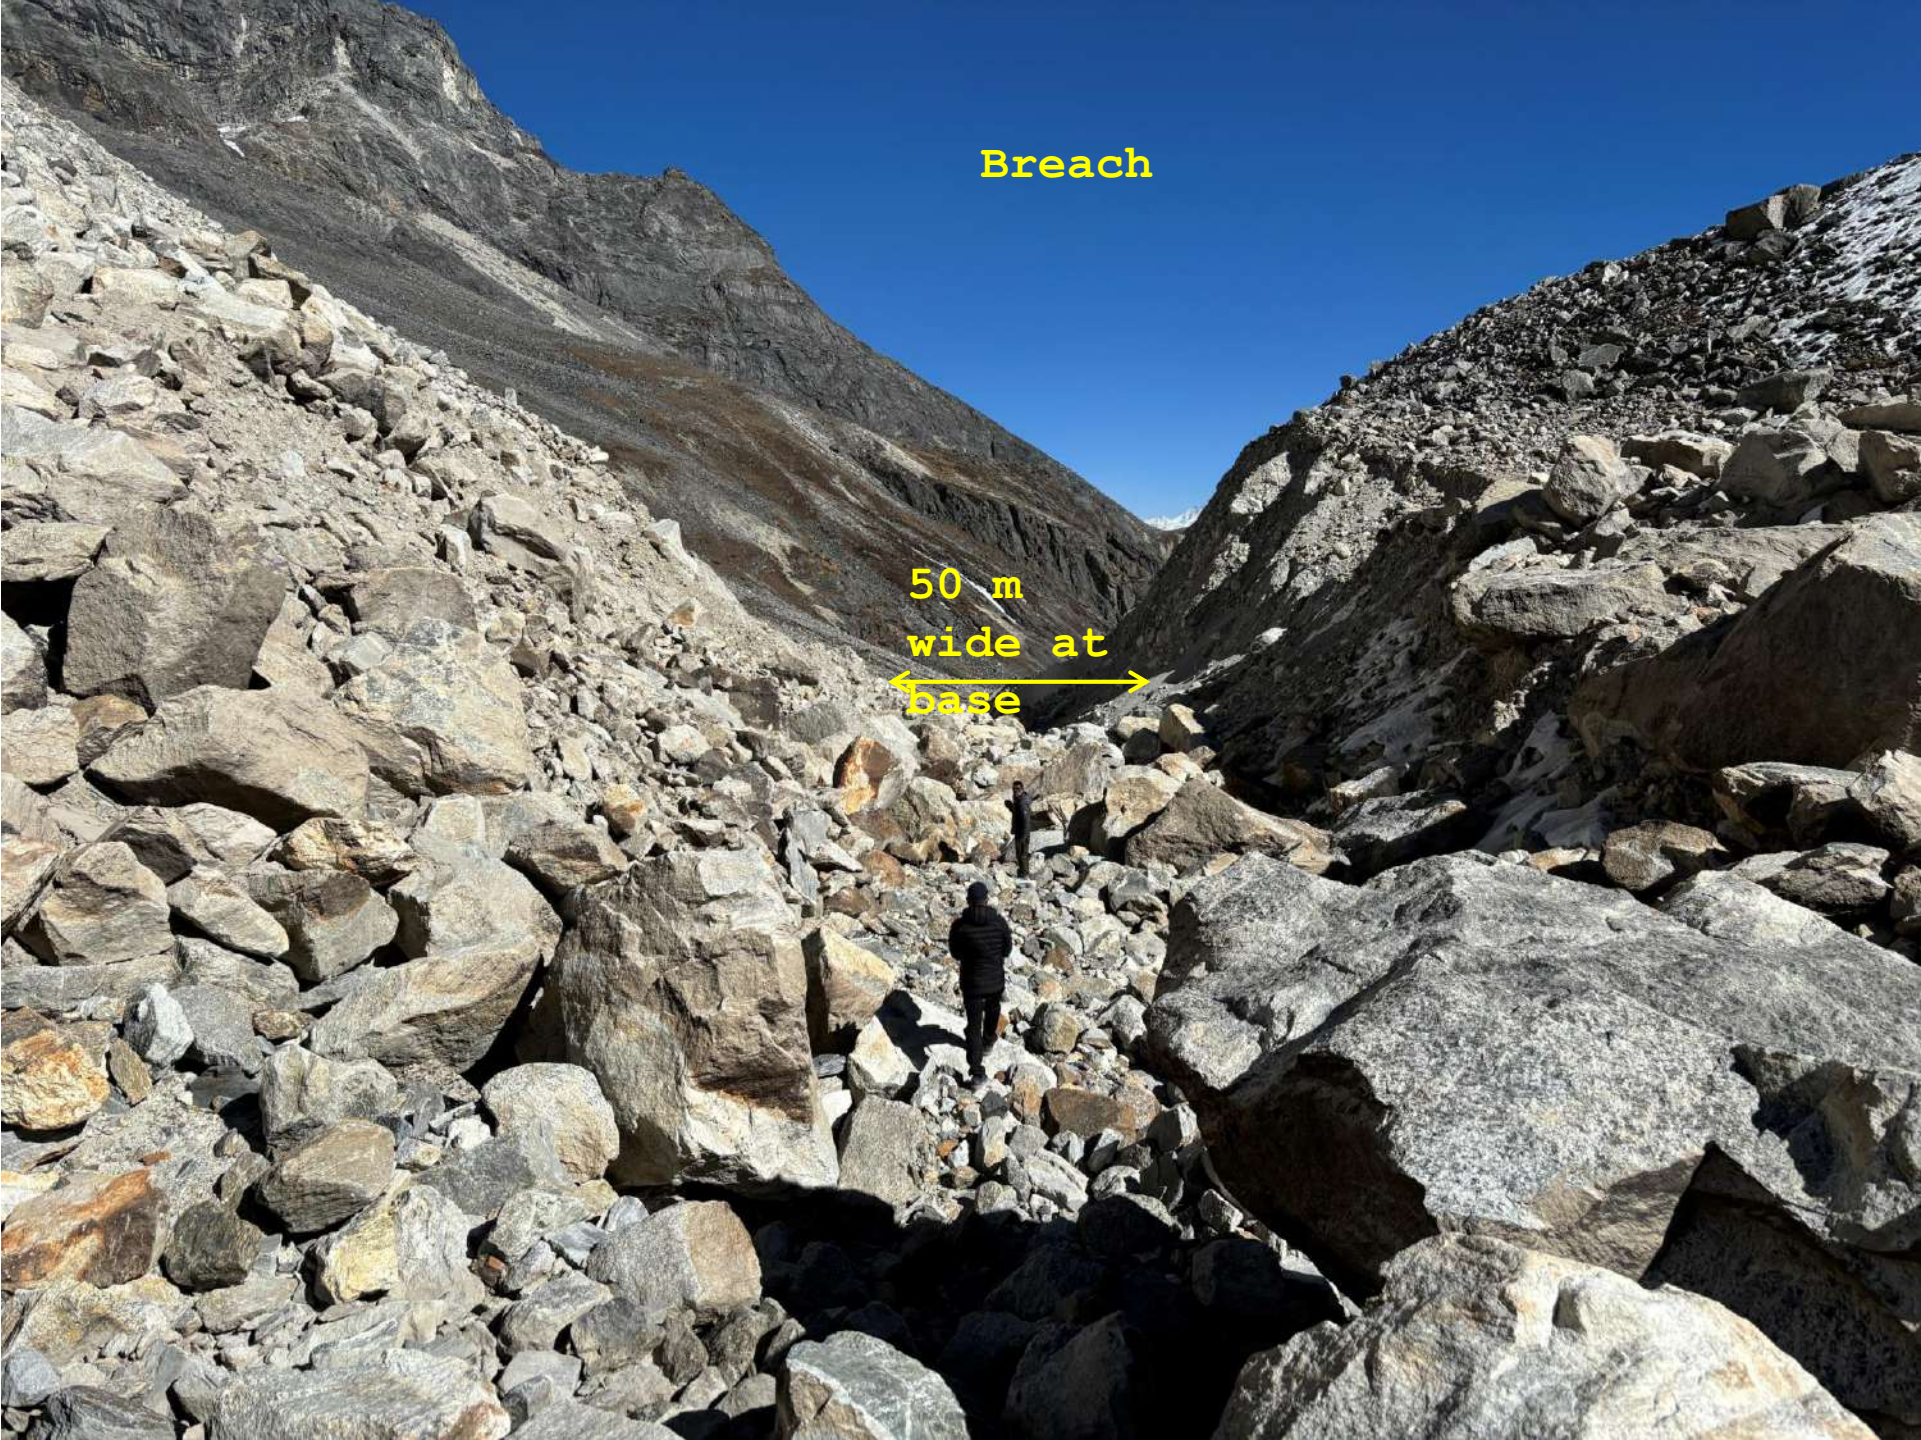
Breach

50 m
wide at
base

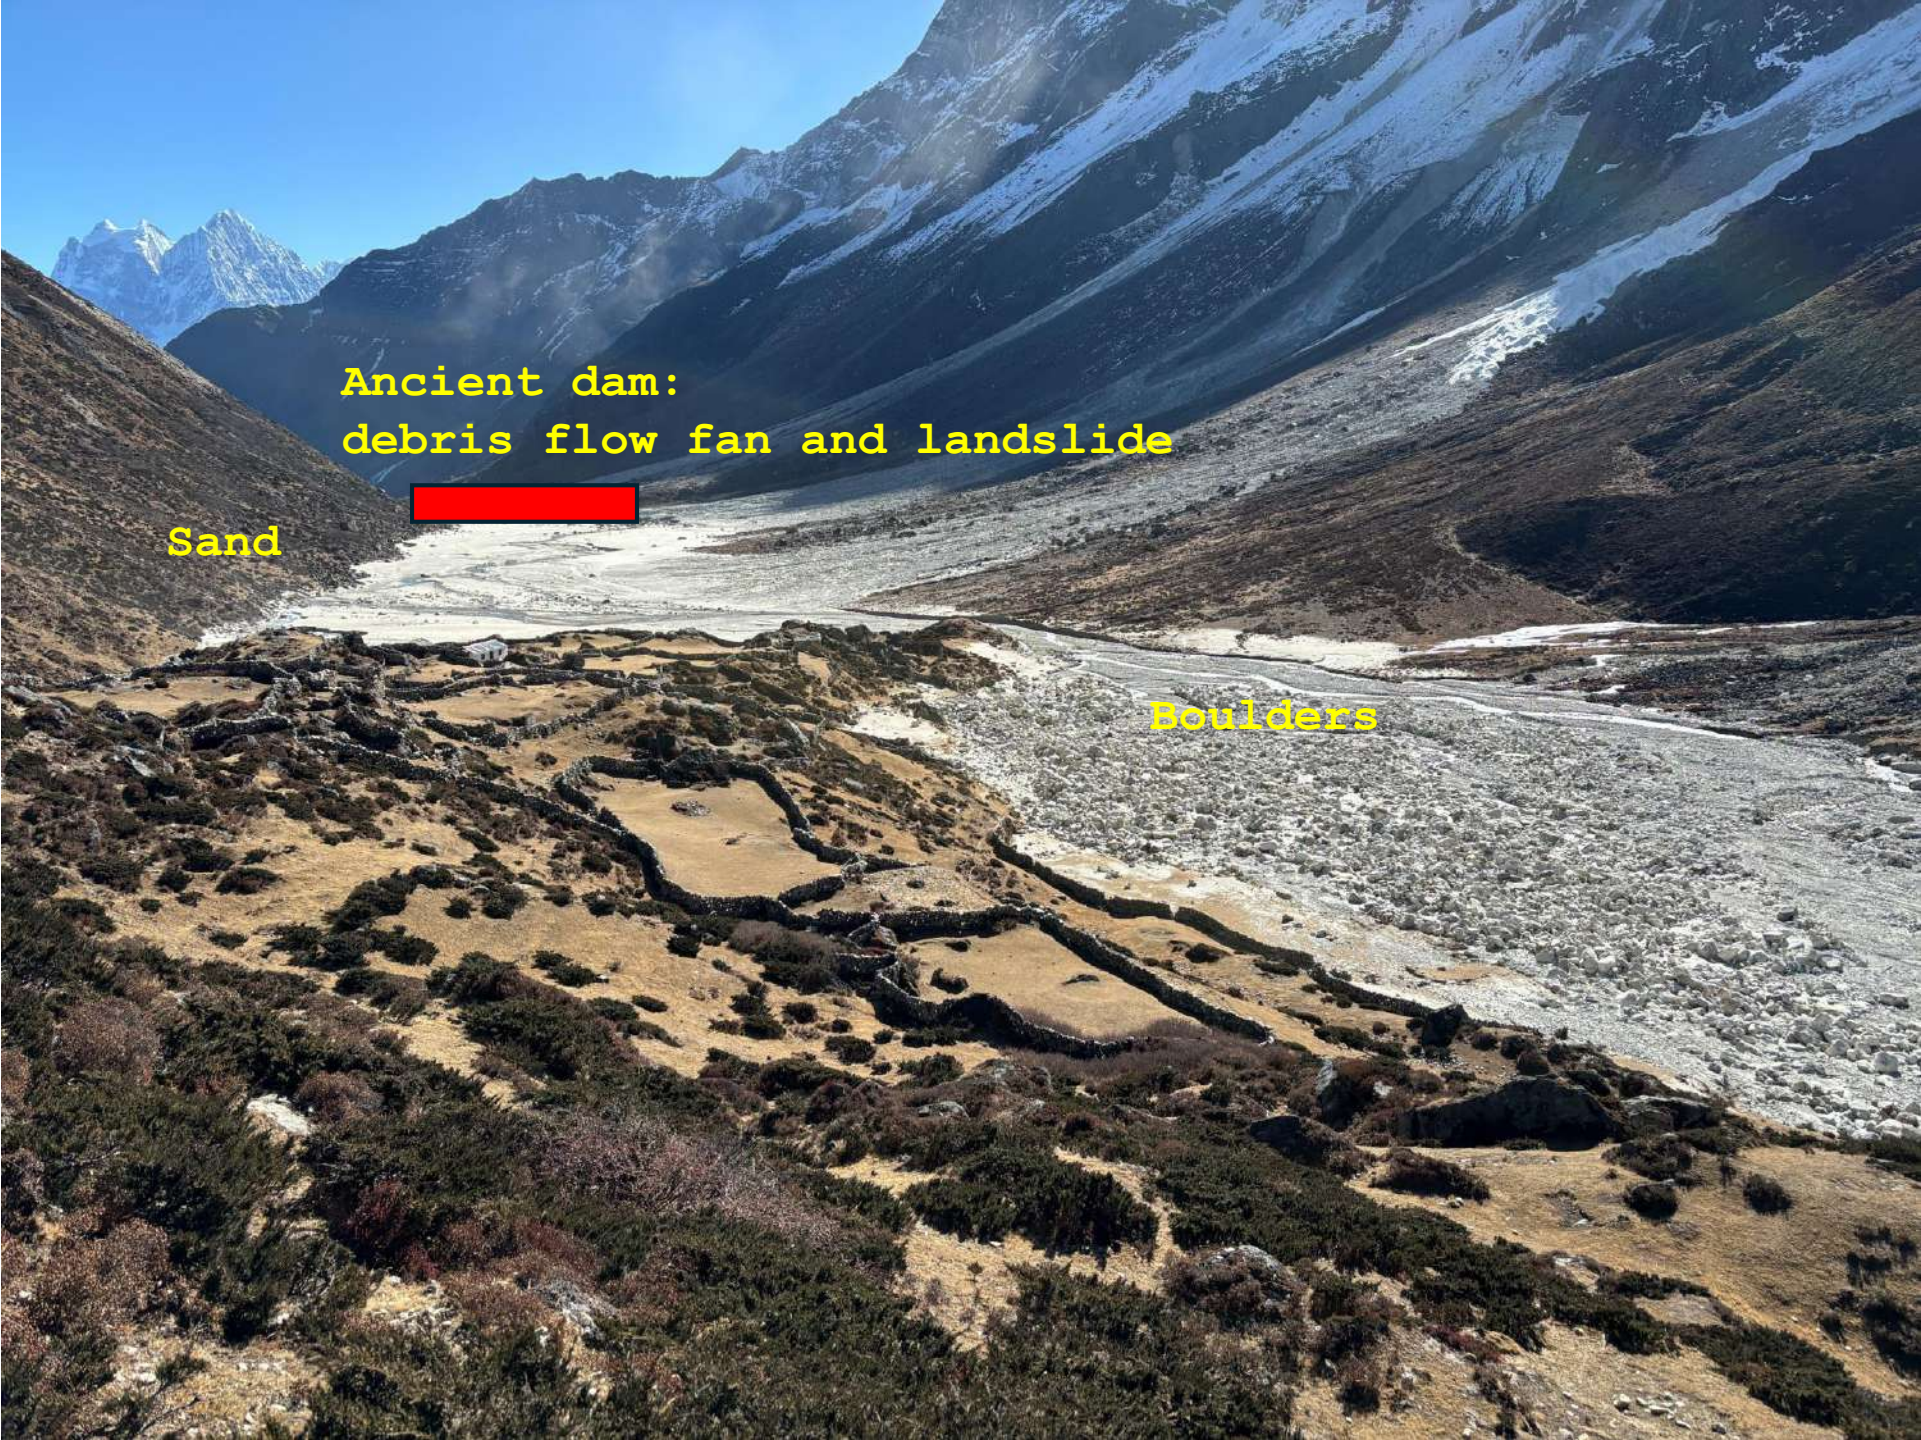
Ancient dam:
debris flow fan and landslide

Sand

Boulders

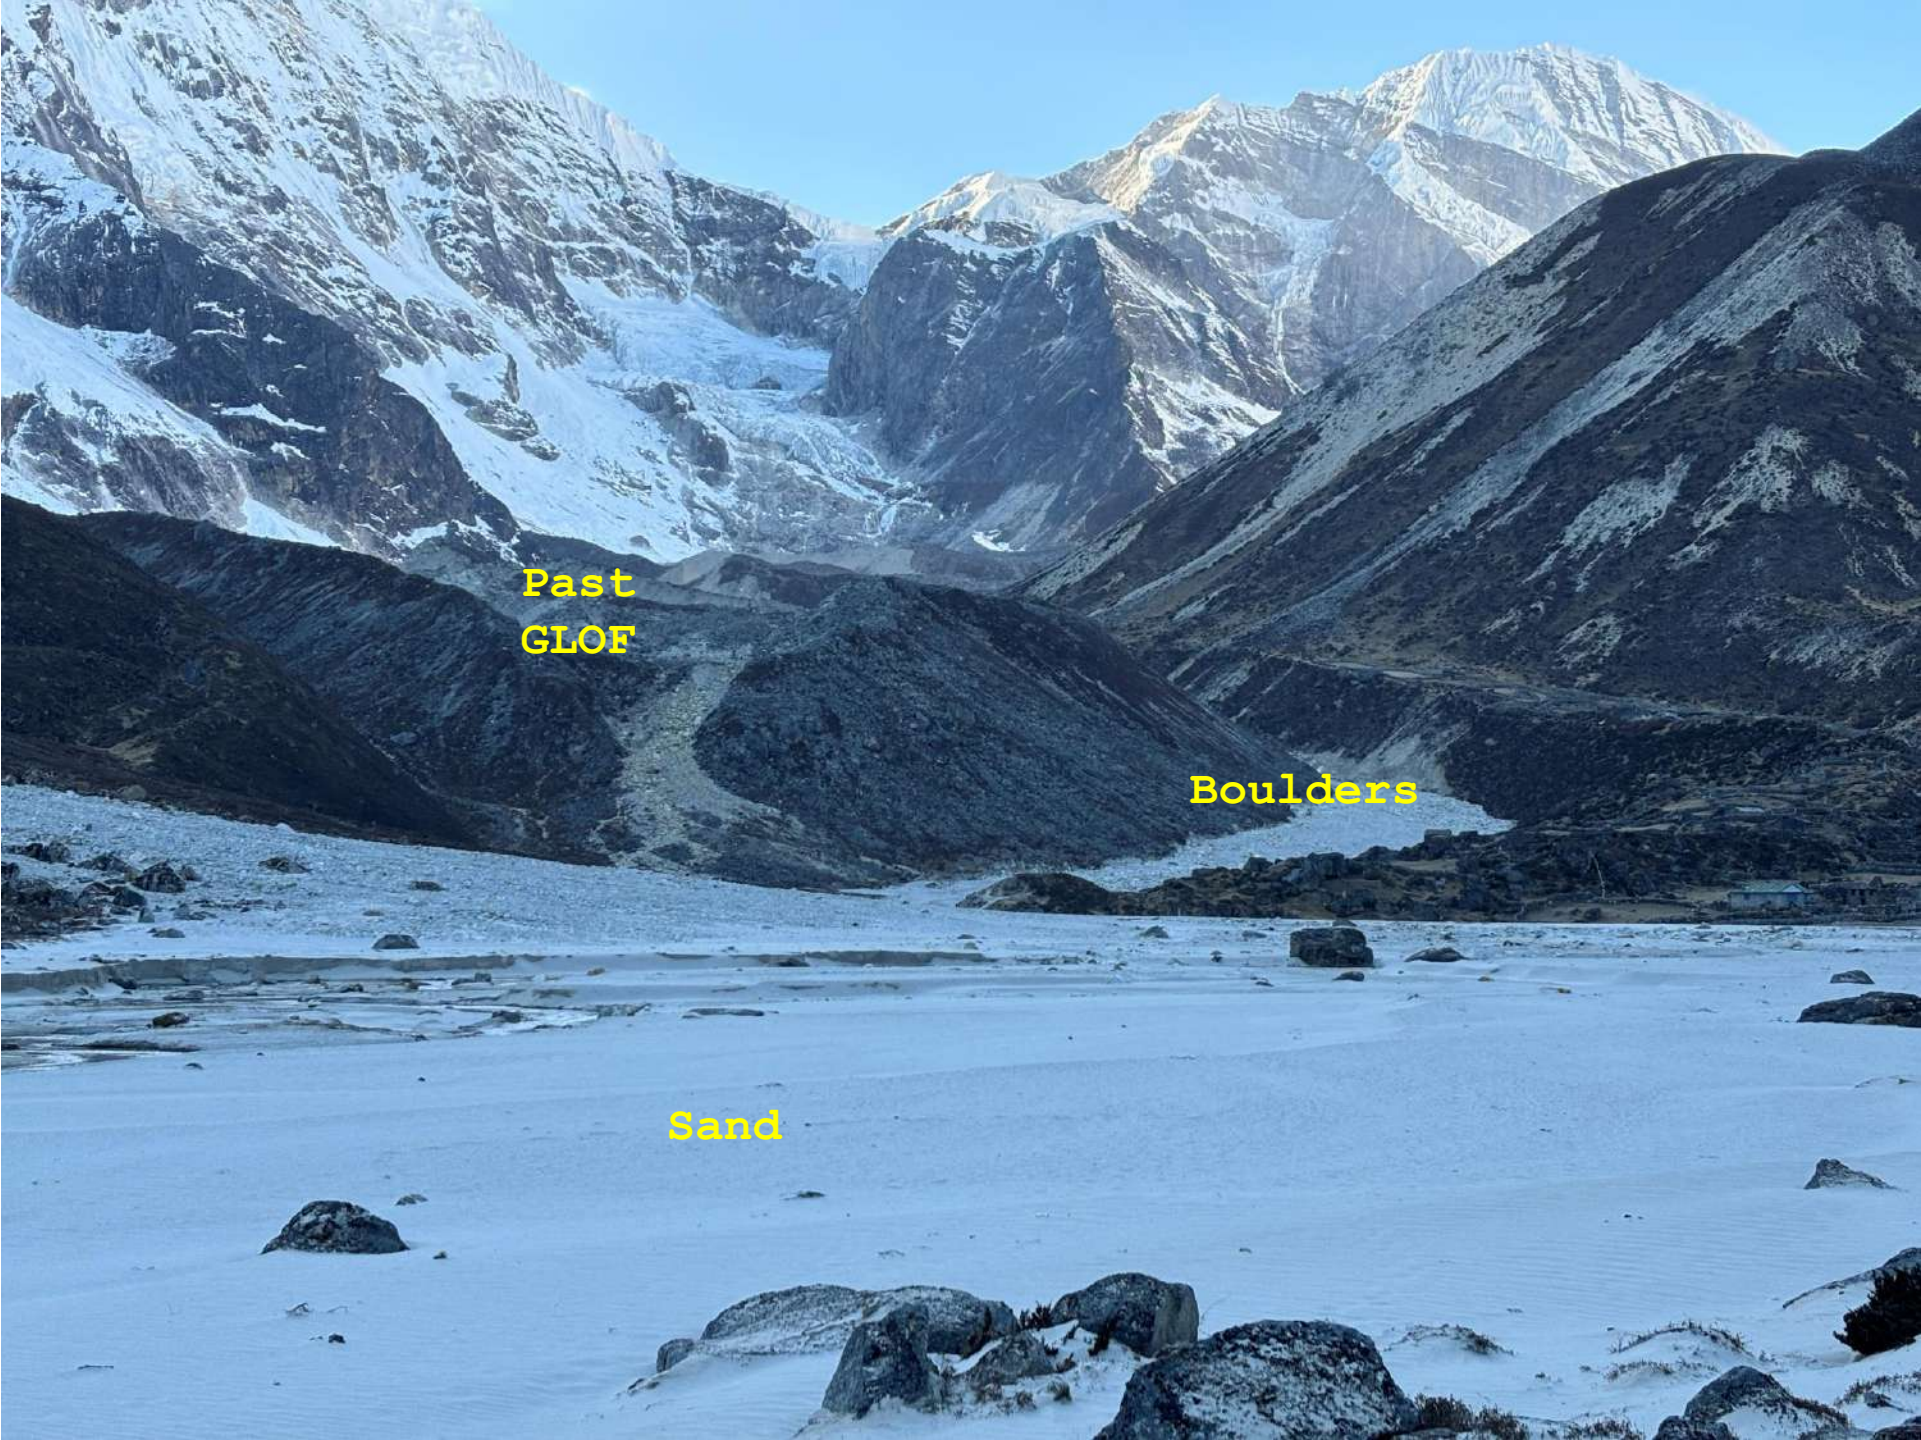
Past
GLOF

Boulders

Sand

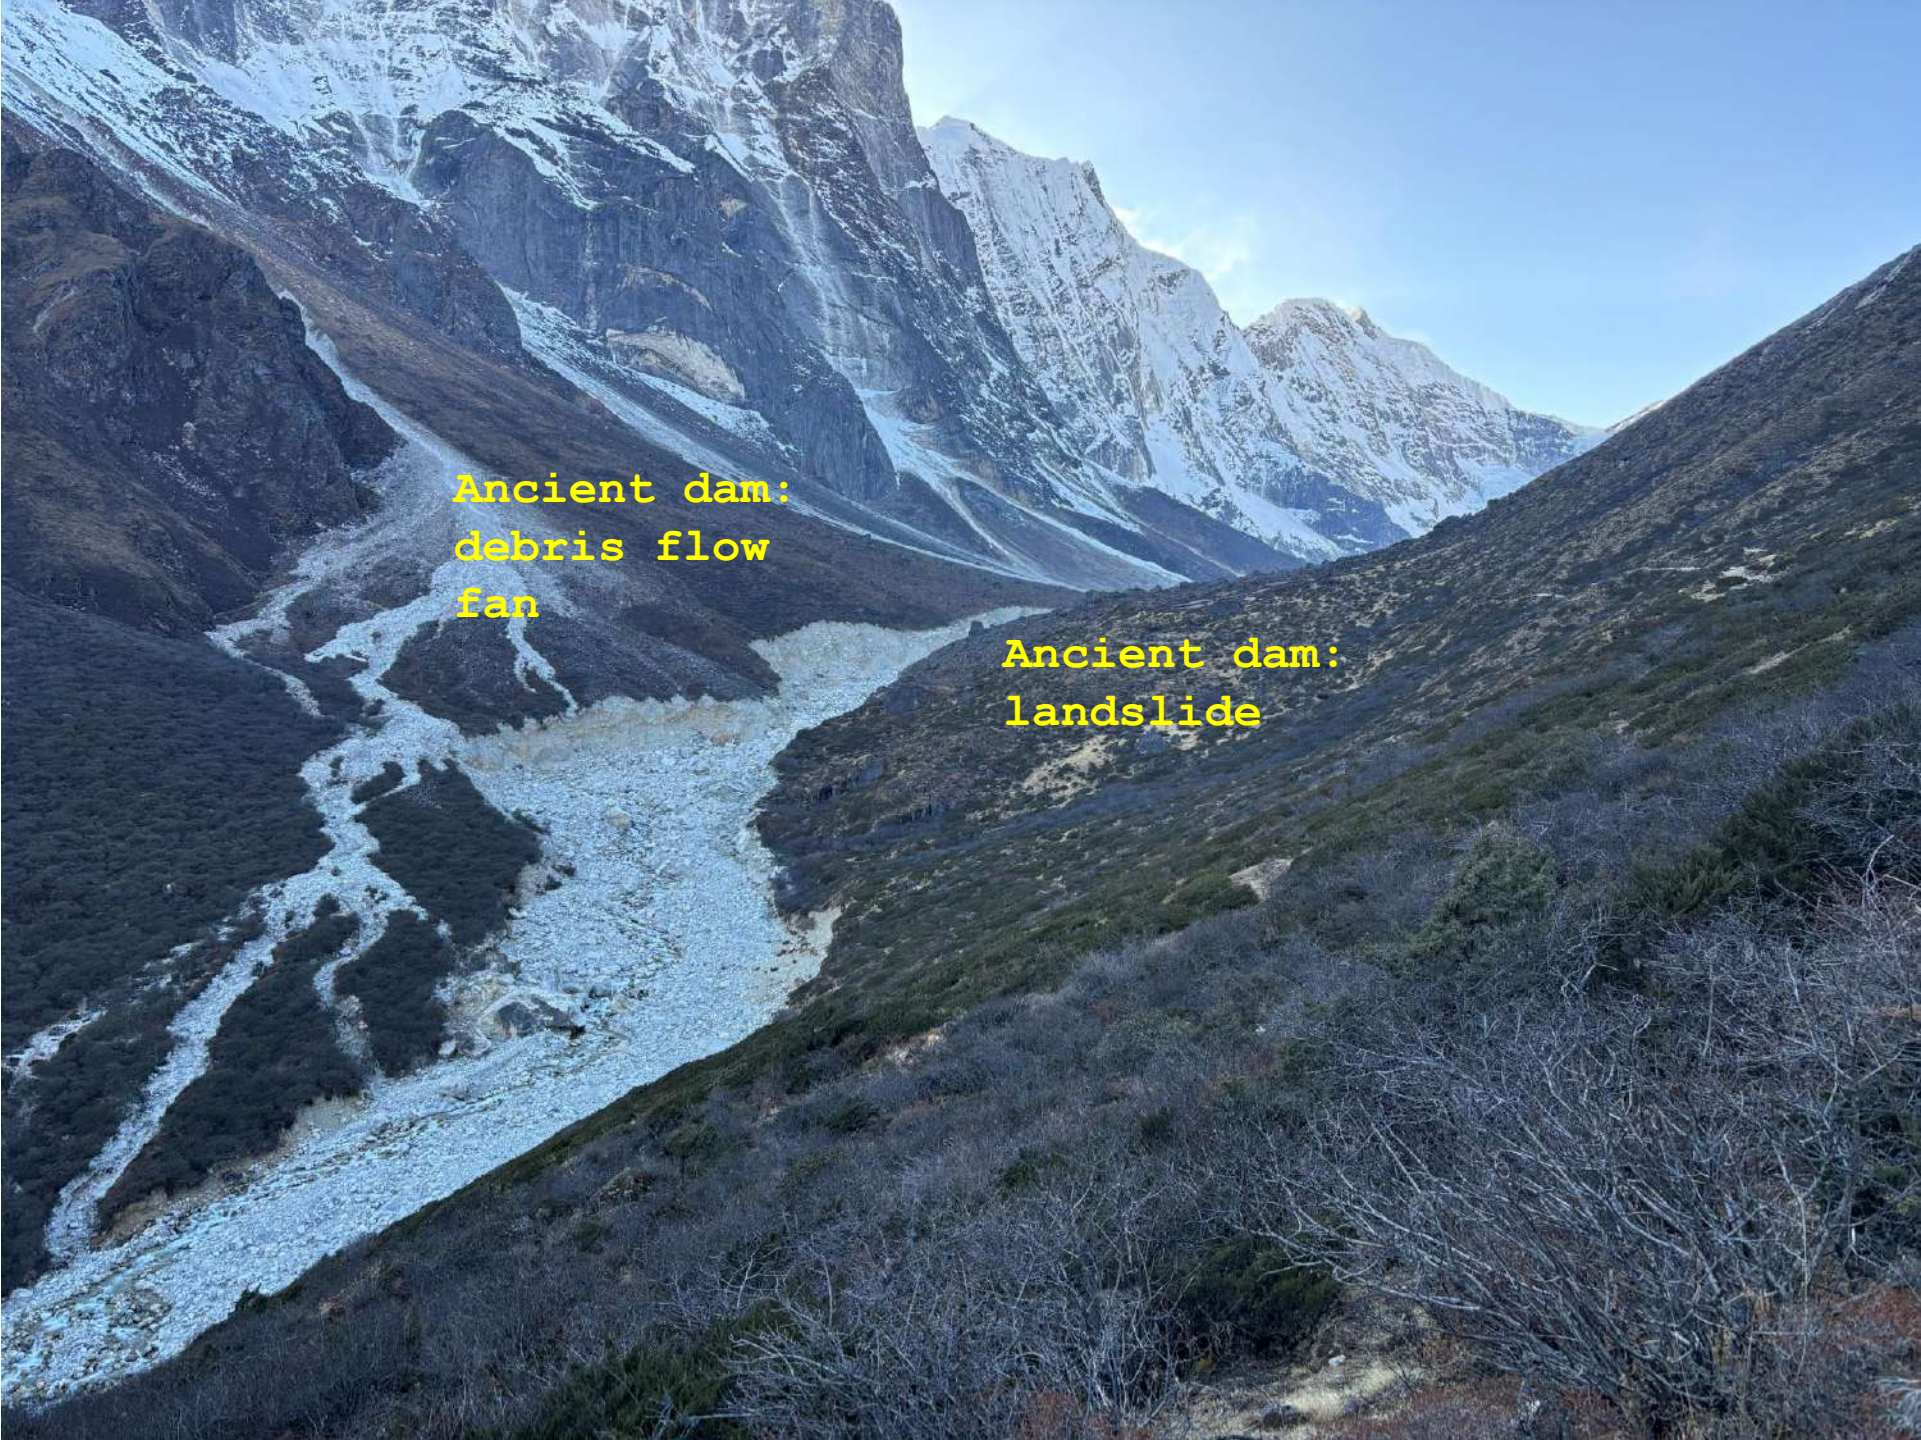
Ancient dam:
debris flow
fan

Ancient dam:
landslide
