“ The Himalayan Hazard: Post-Event Assessment of Thame's GLOF ”

Thame GLOF Field-Based Assessment

Keshab Sharma, PhD
BGC Engineering Inc., Canada

December 13, 2024

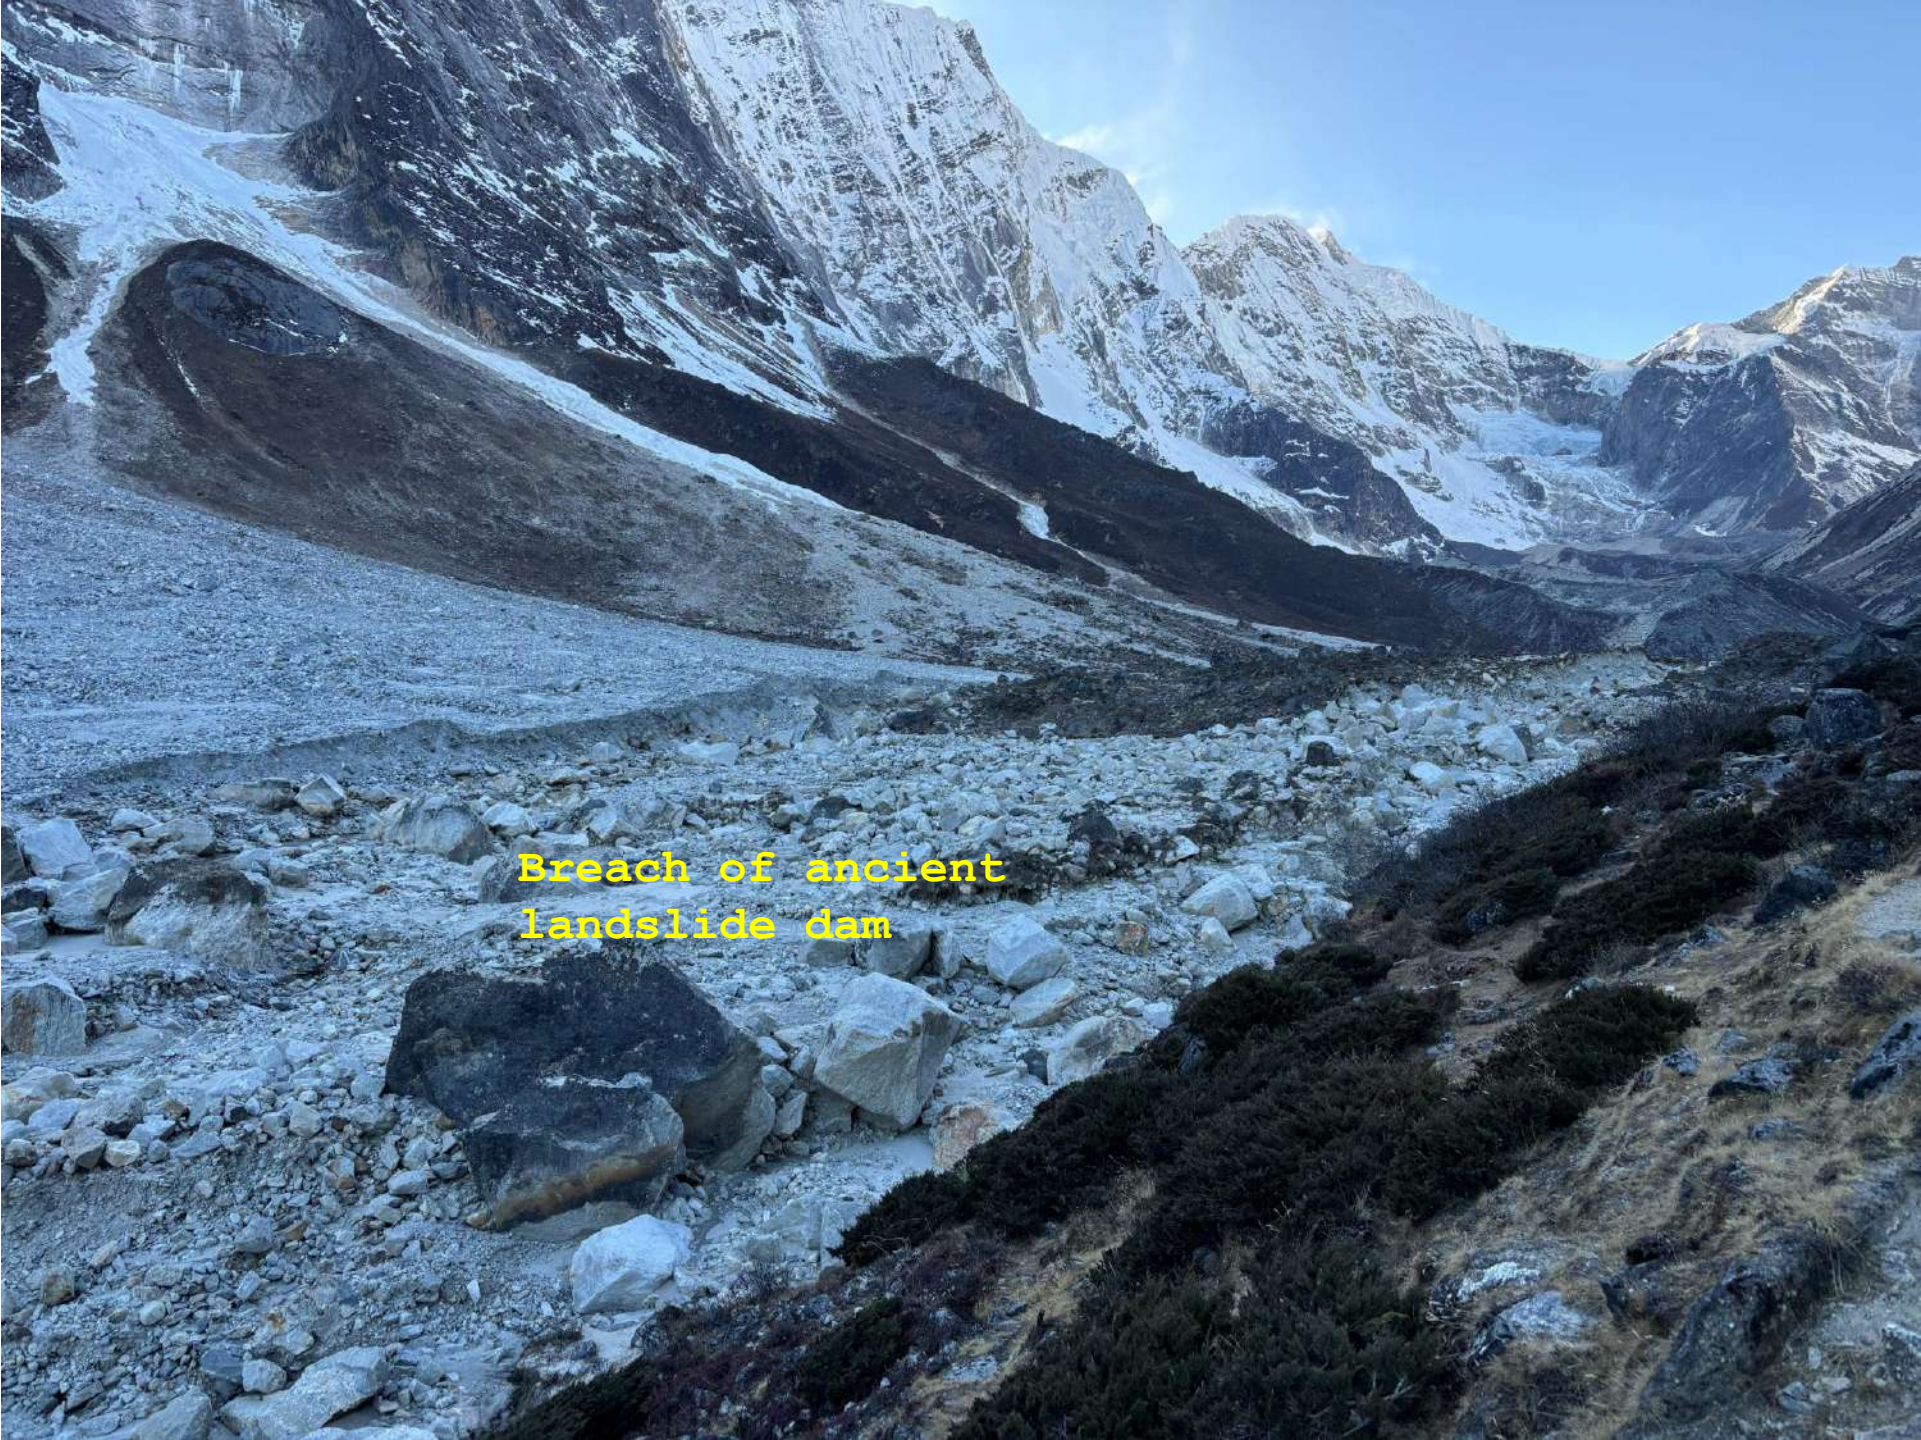
Breach of ancient
landslide dam

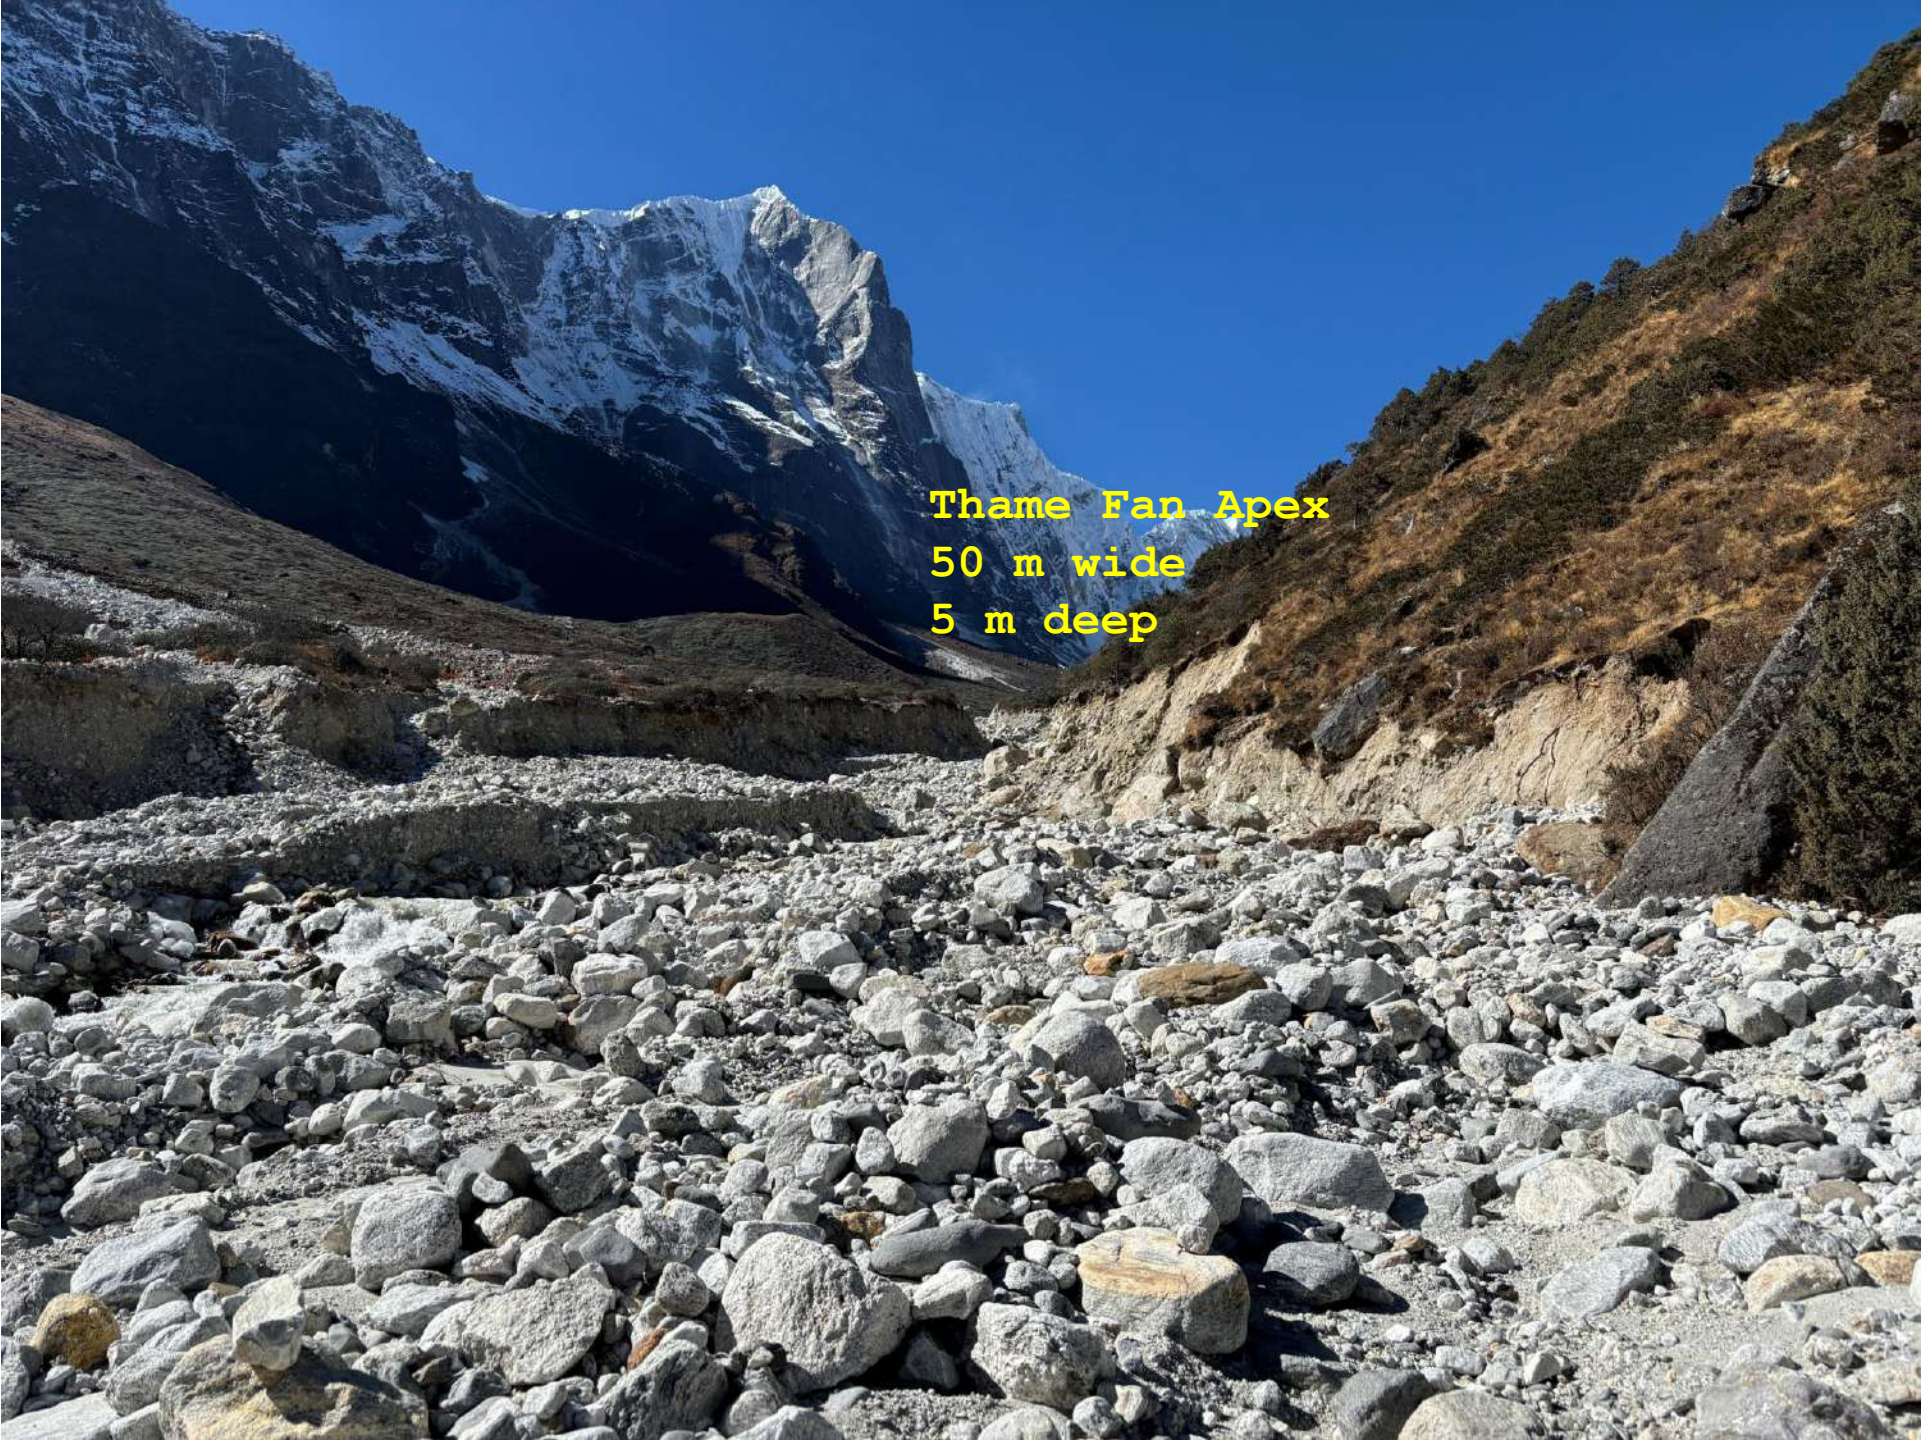
Thame Fan Apex
50 m wide
5 m deep

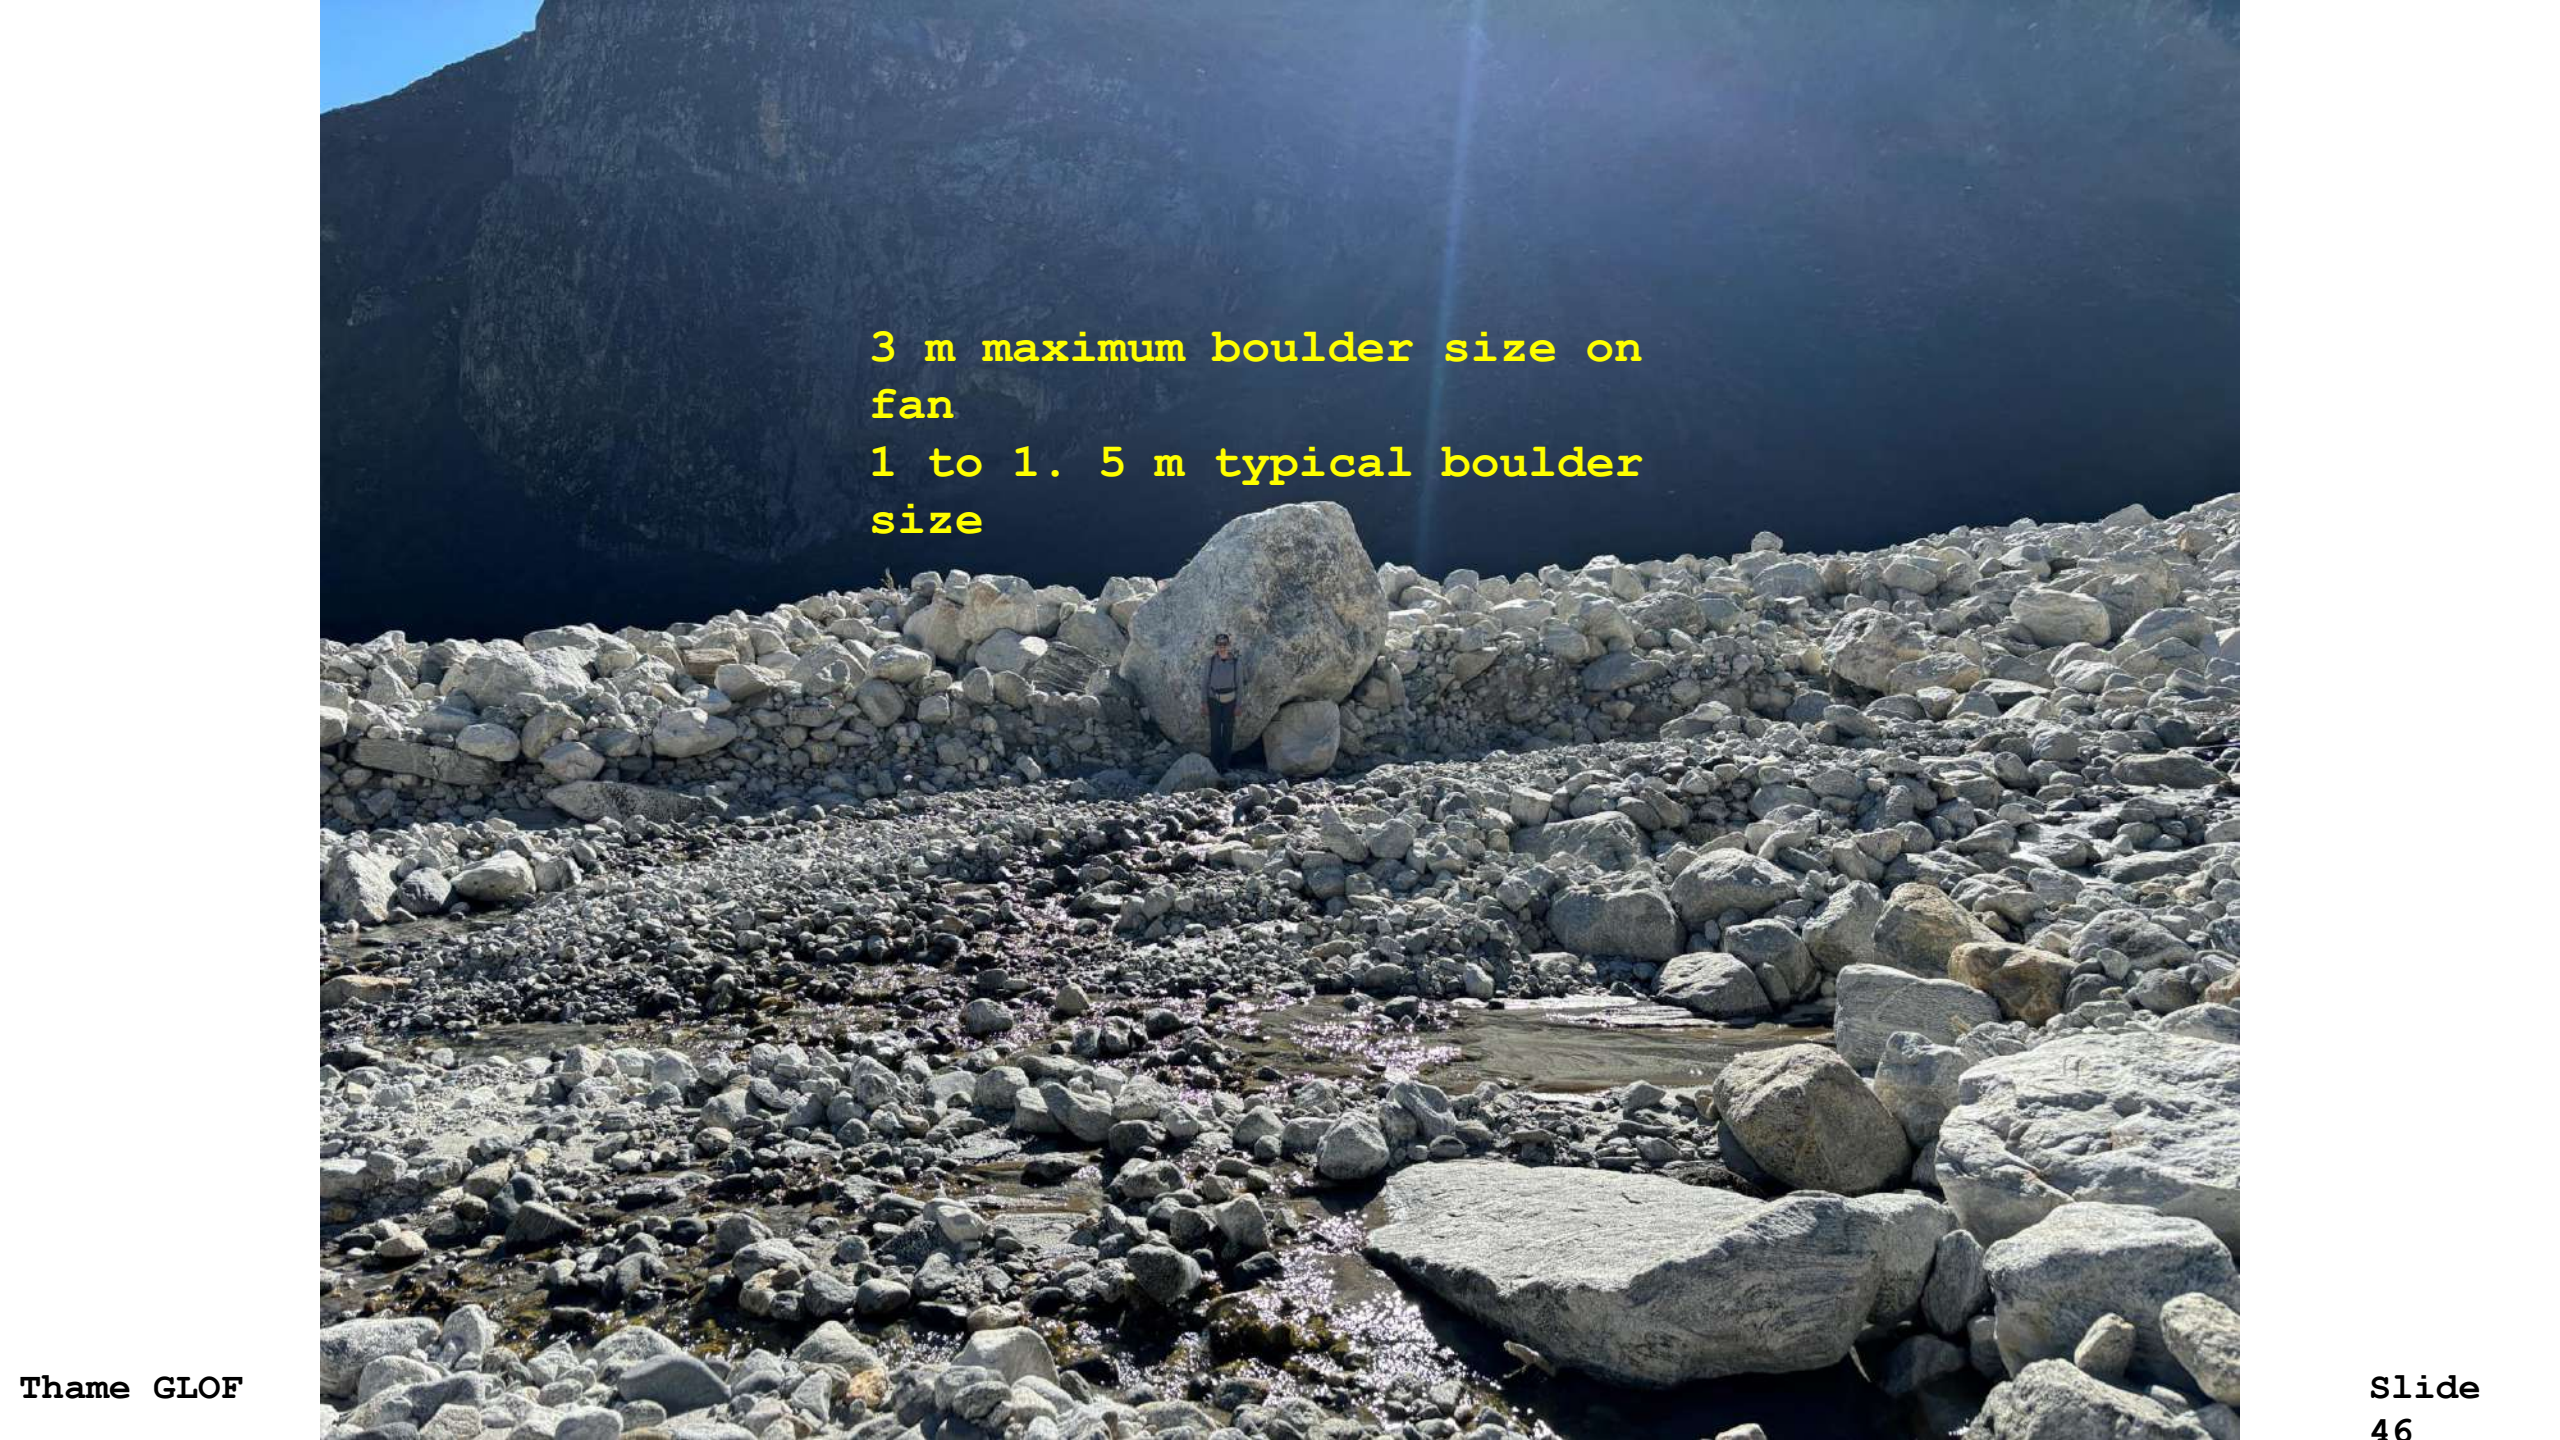
3 m maximum boulder size on
fan
1 to 1.5 m typical boulder
size

Ancient debris flood deposits in upper fan

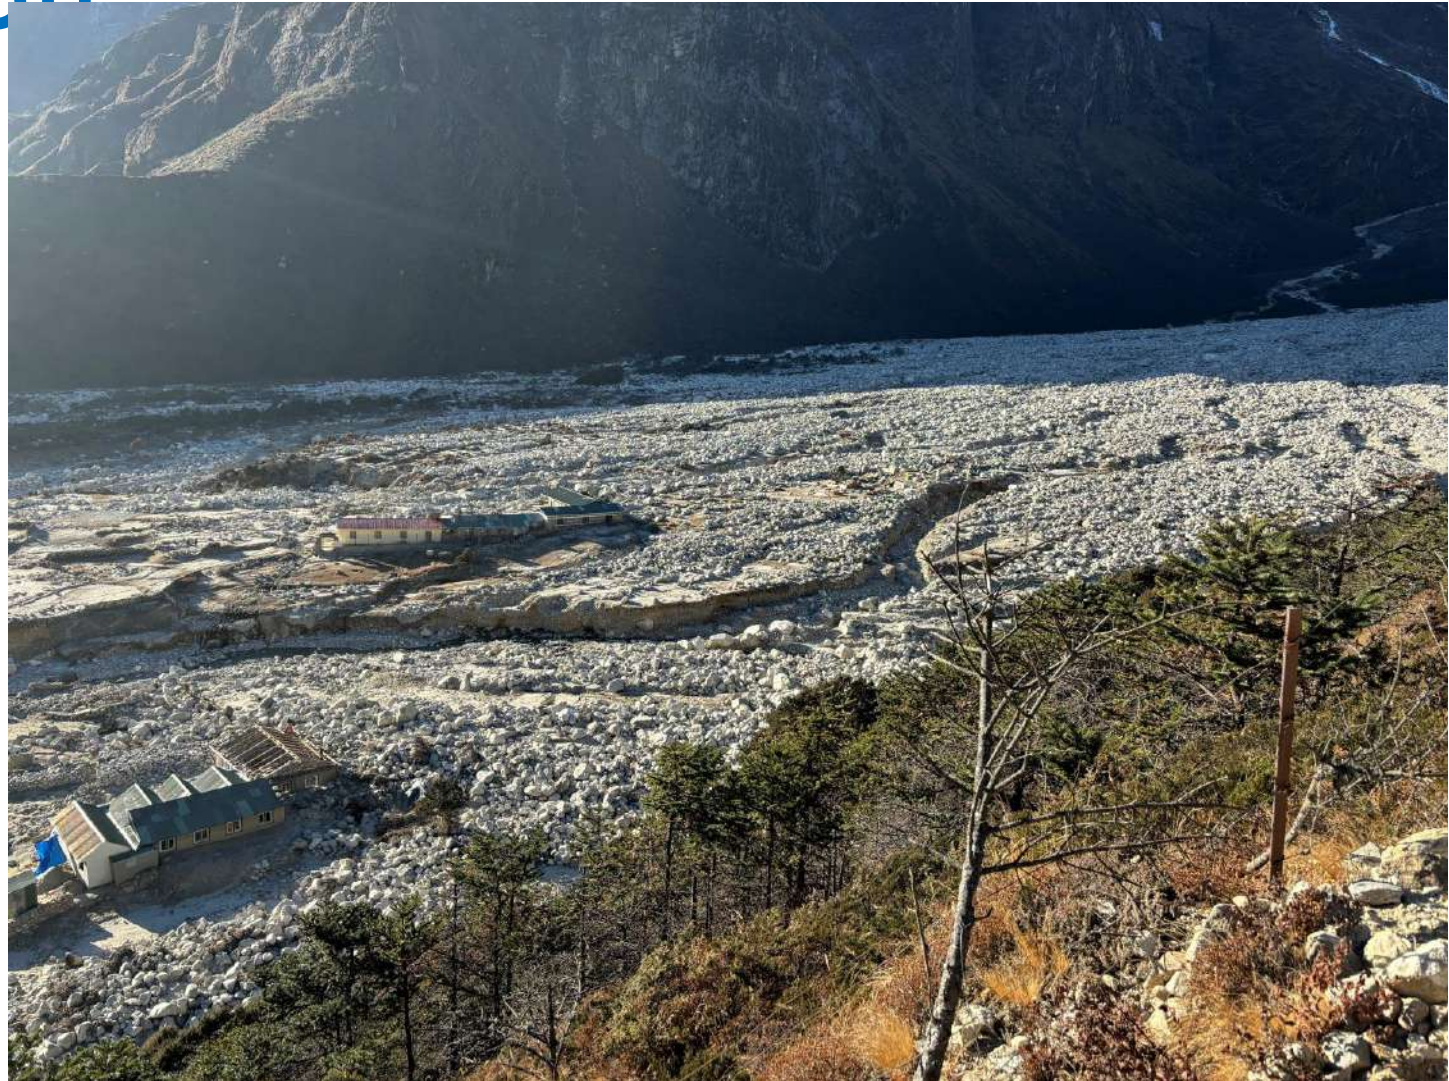
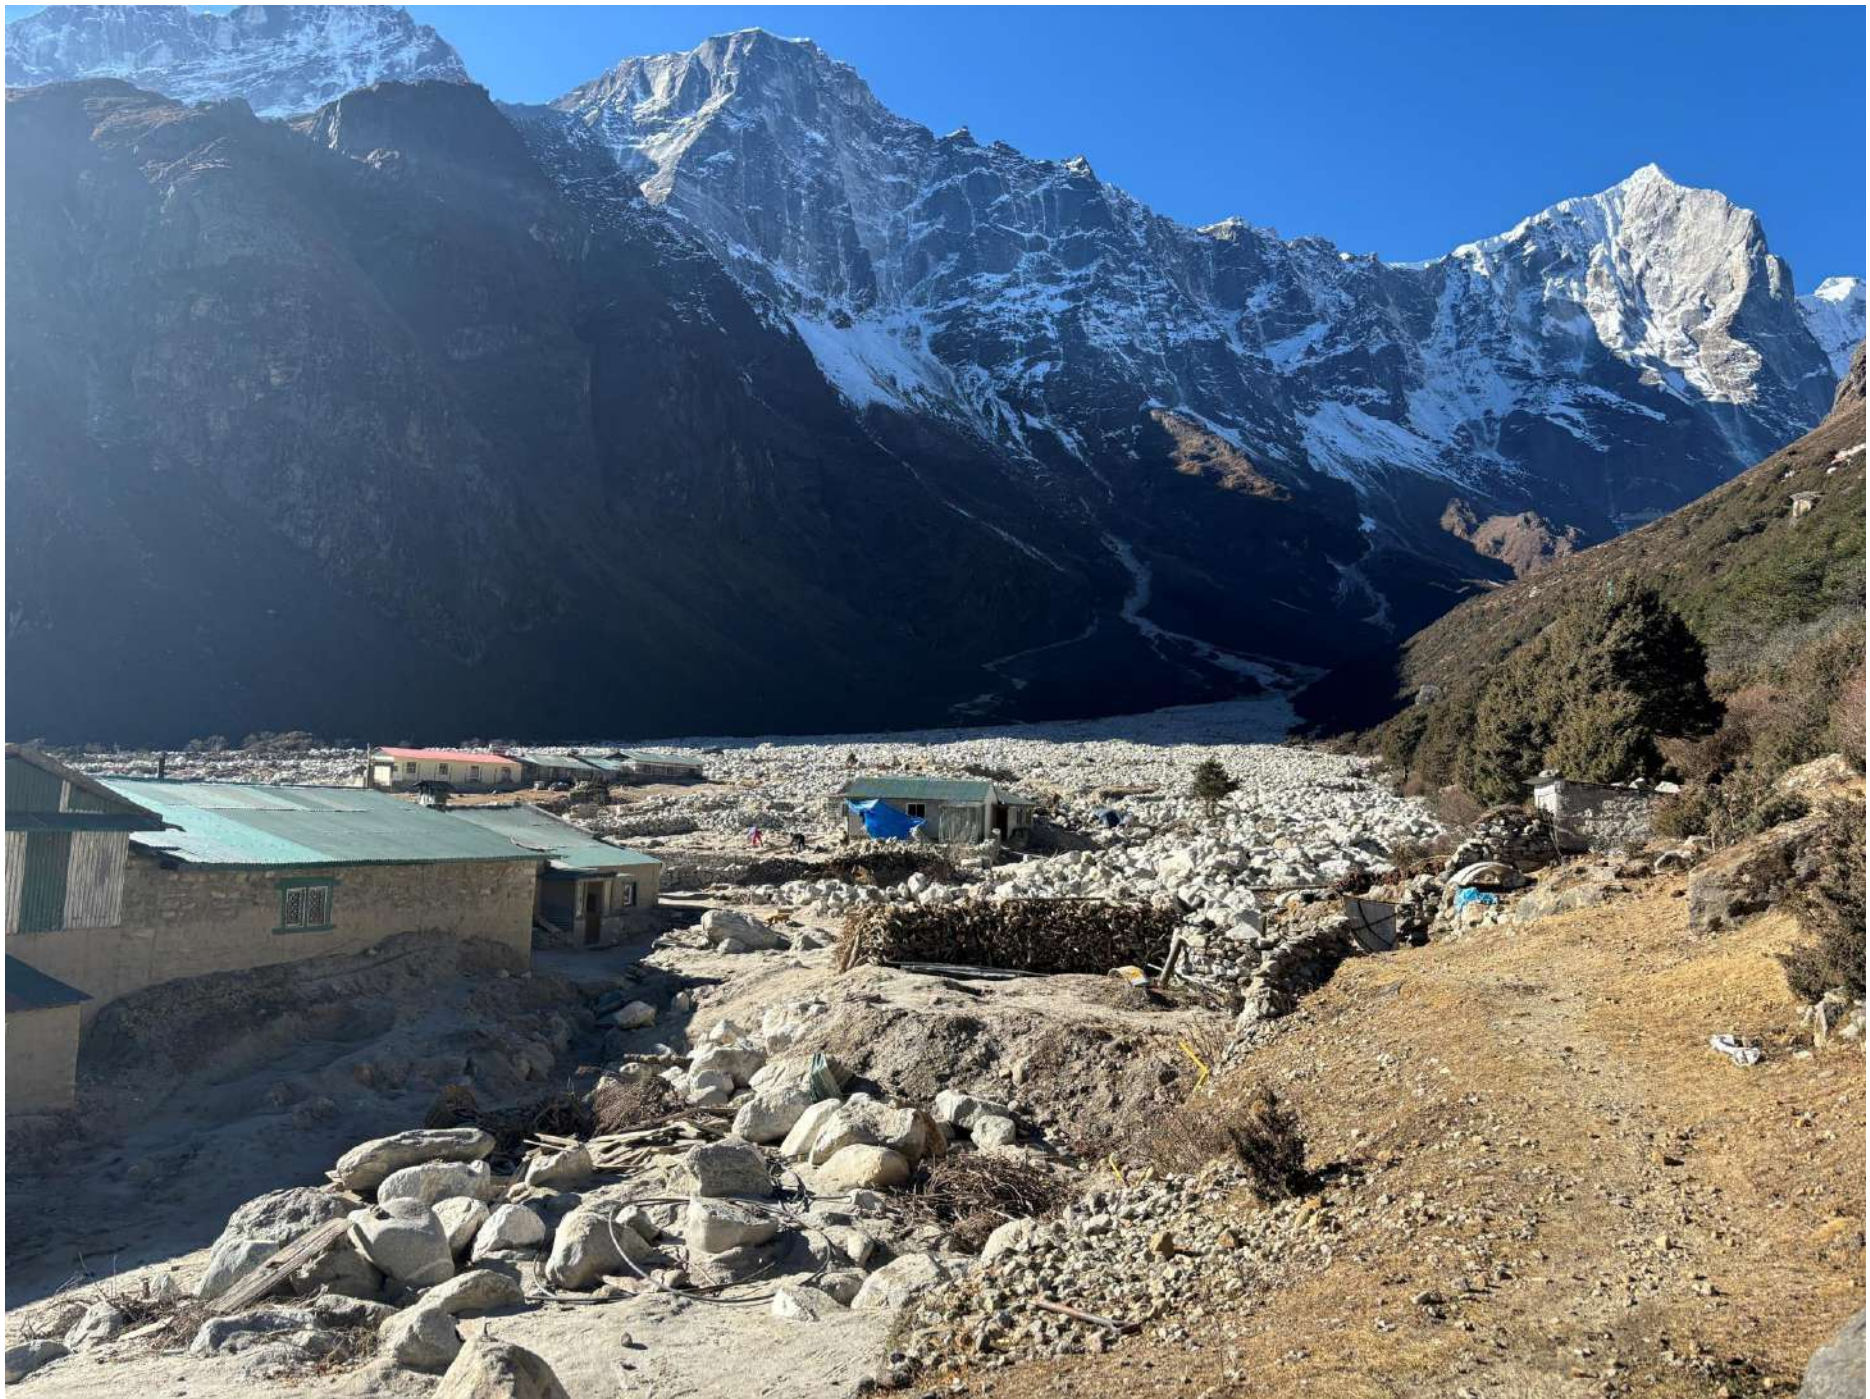
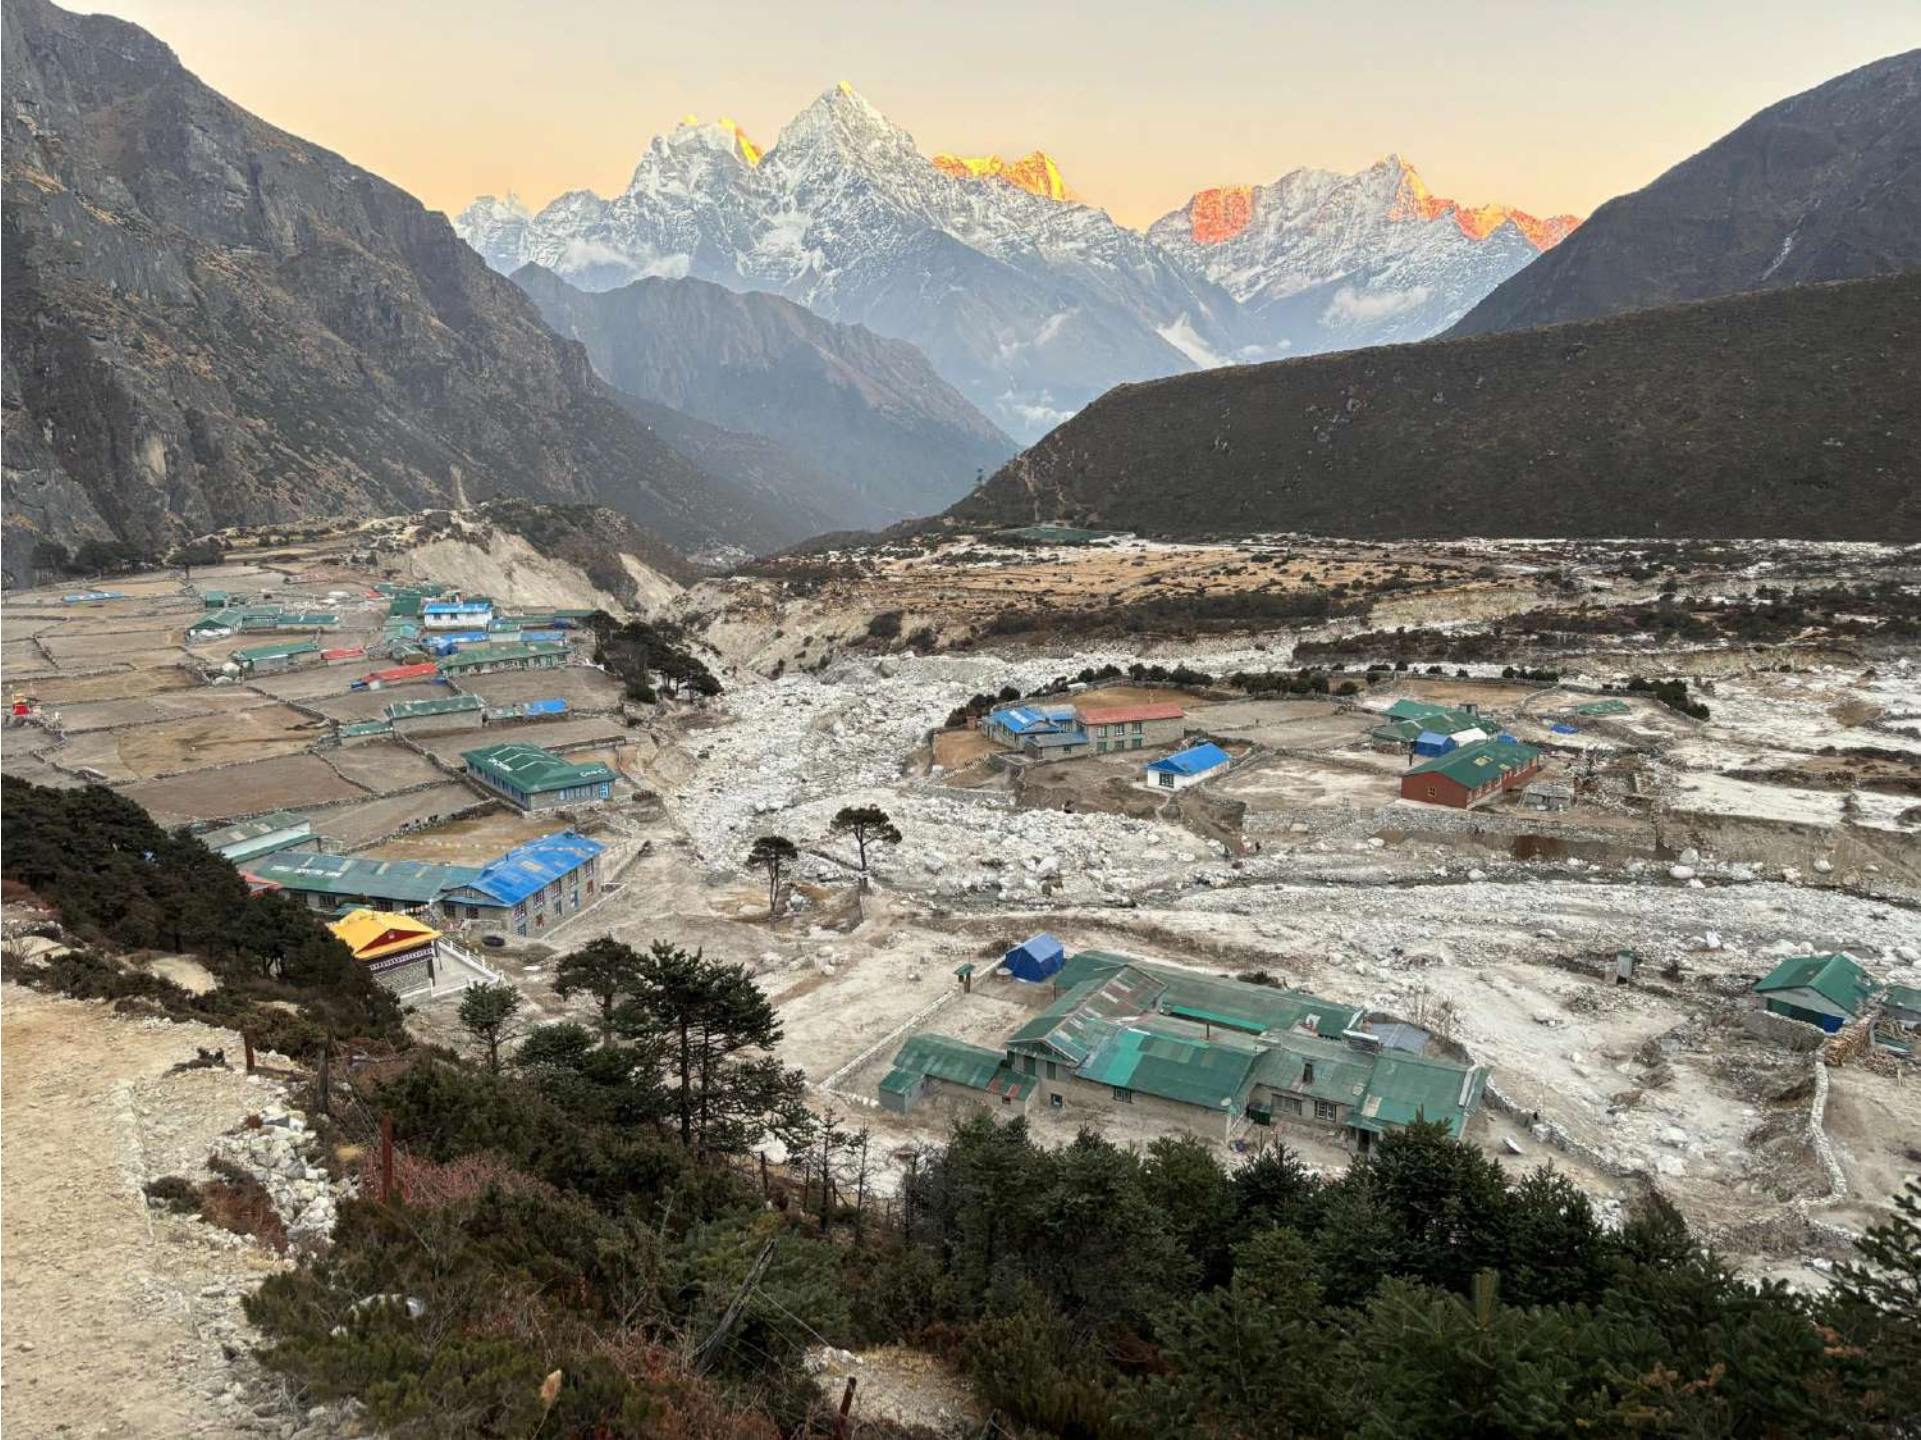
Bank erosion near Debris Fan

- New channels direct flows toward community
- Erosion of banks in heavy flow undermines buildings
- Buildings collapse into the channel

- Build diversion berms on upper fan to encourage flow towards south channels, away from the community
- Build erosion protection at critical slopes within the community
 - Masonry walls
 - Gabion walls

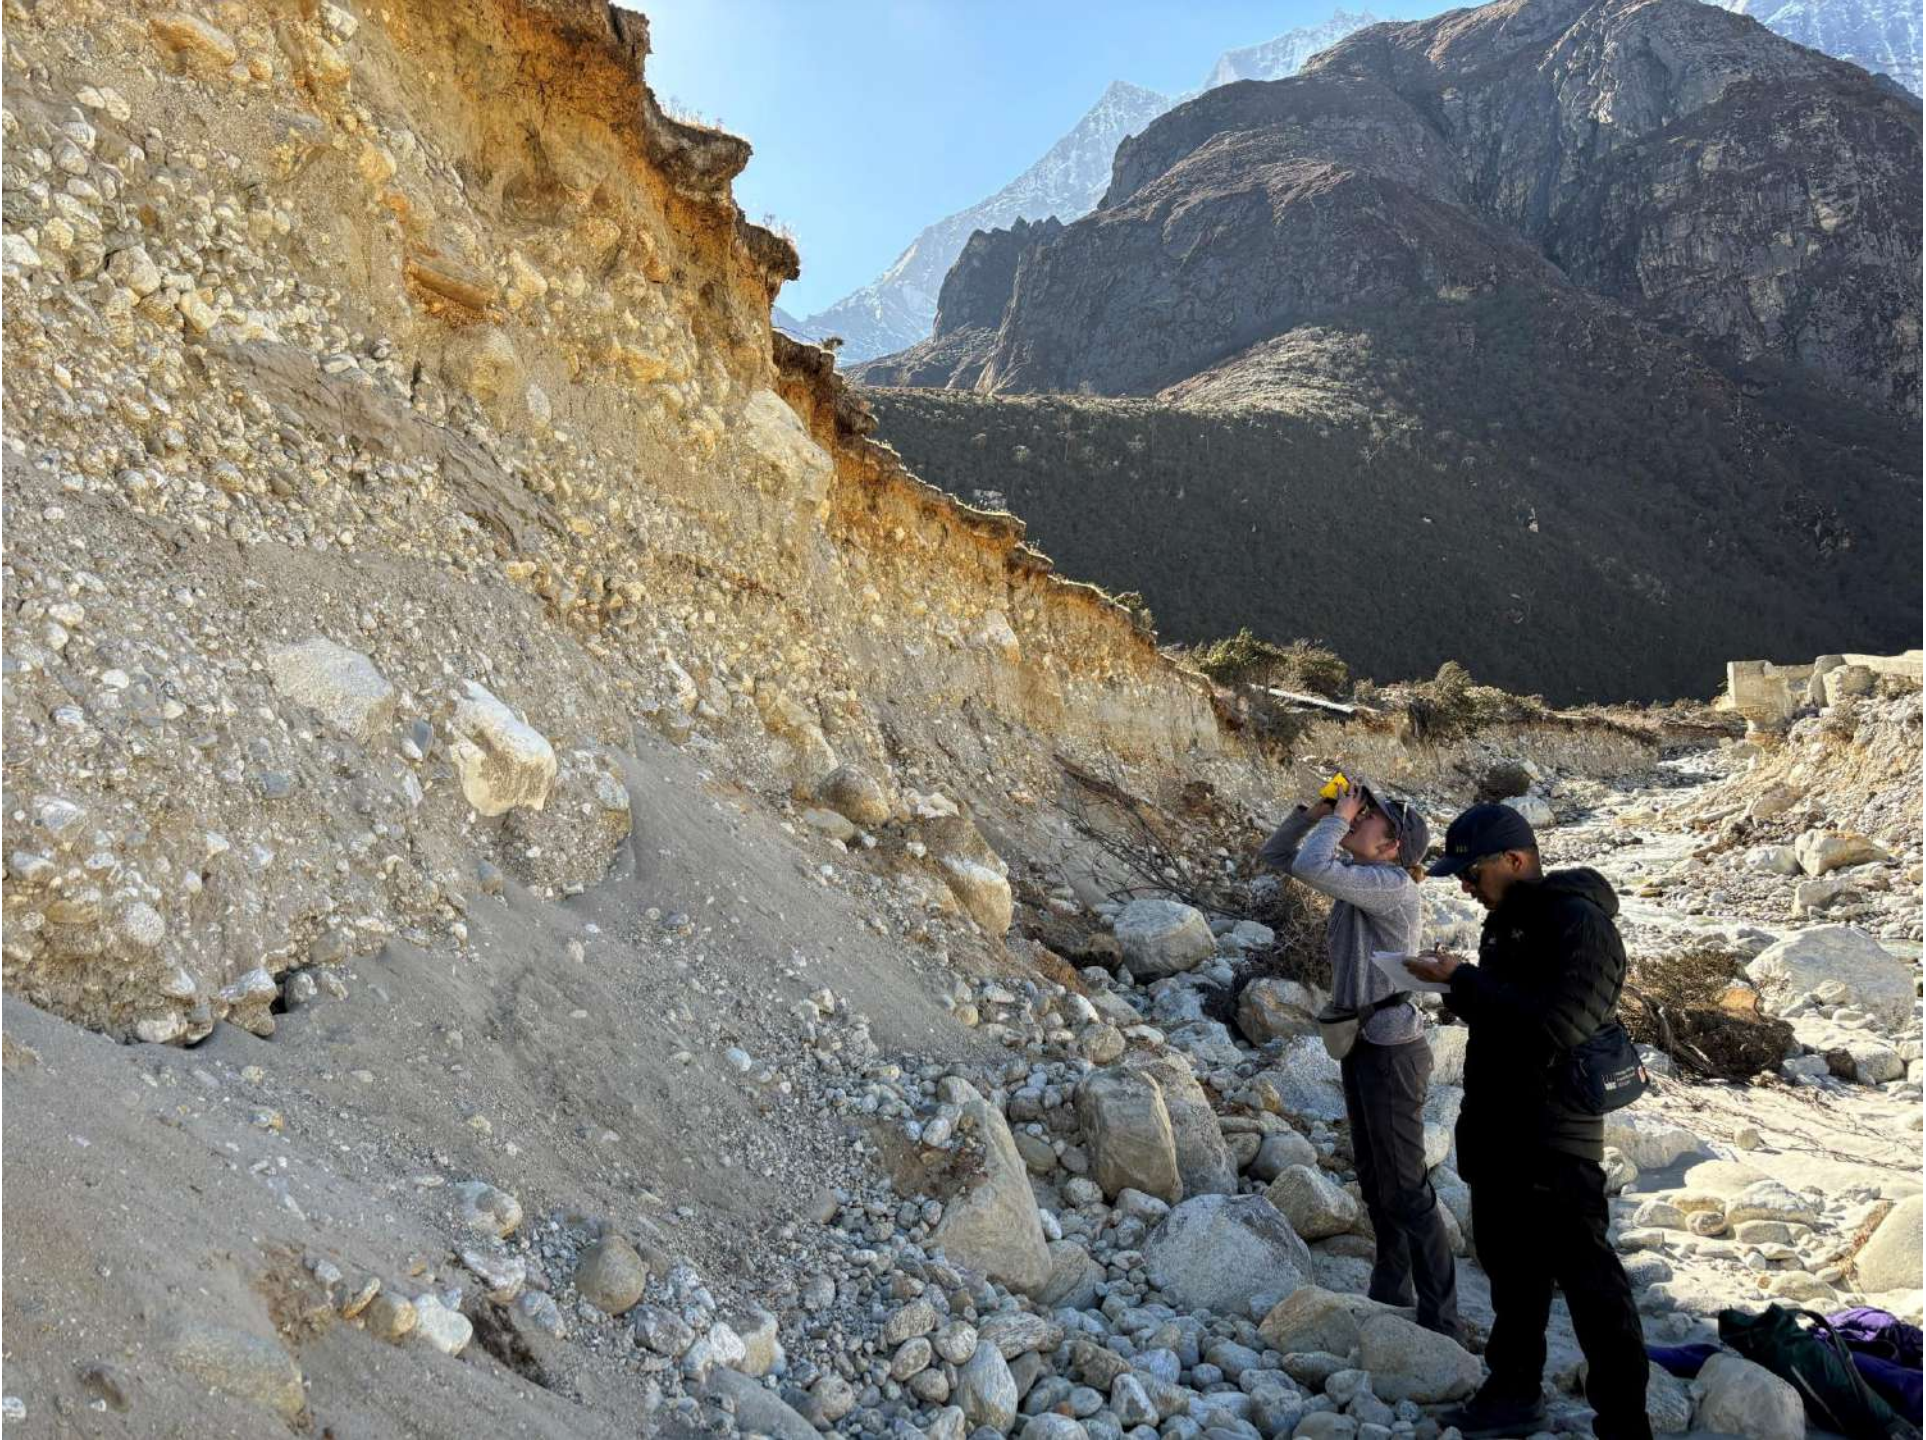
GRAVEL, Fine to Coarse, cobbles, Sandy, well graded, loose, rounded, gray and whitish, dry, heterogeneous, classic structure, maximum size 300 mm

ORGANIC SOIL, Fine-grained, traces of roots, low plastic, soft, black, wet, soft

SAND, Coarse sand, traces of gravel and cobbles, gap-graded, loose/compact, rounded, gray (with reddish lenses with corrosion), dry, non-stratified, poorly cemented

ORGANIC SOIL, Fine-grained, fine sand, wet, non-plastic, black, trace of roots, soft

GRAVEL: Fine to Coarse, Sandy, traces of cobbles, well graded, loose, rounded, gray (and with reddish lenses with corrosion), dry, heterogeneous, classic structure, traces of roots, maximum size 300 mm

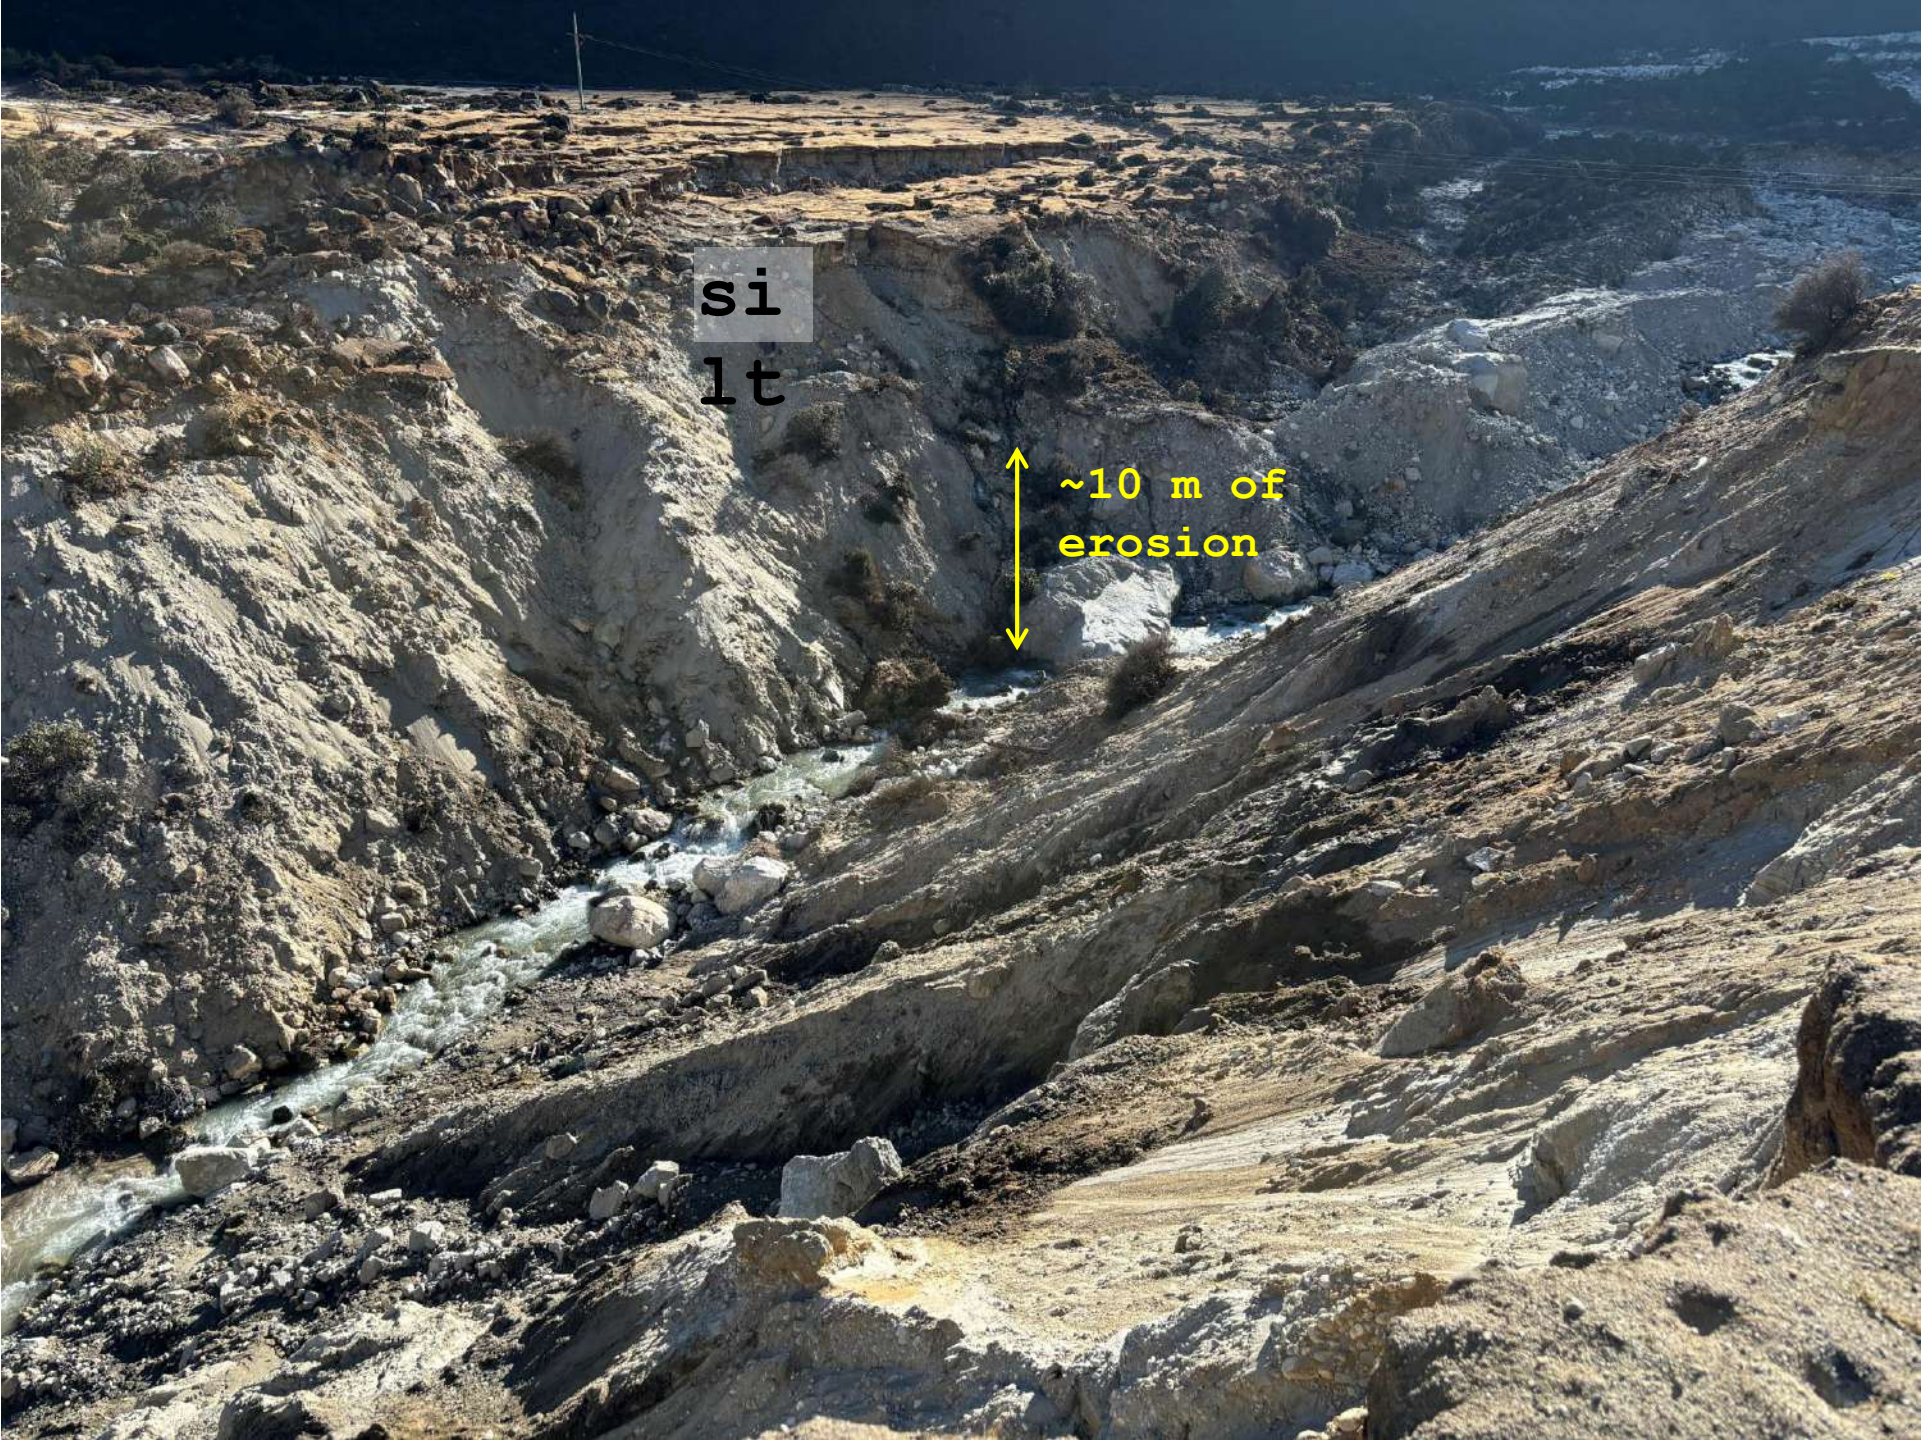
silt

~10 m of erosion
