“ The Himalayan Hazard: Post-Event Assessment of Thame's GLOF ”

Thame GLOF Field-Based Assessment

Keshab Sharma, PhD
BGC Engineering Inc., Canada

December 13, 2024

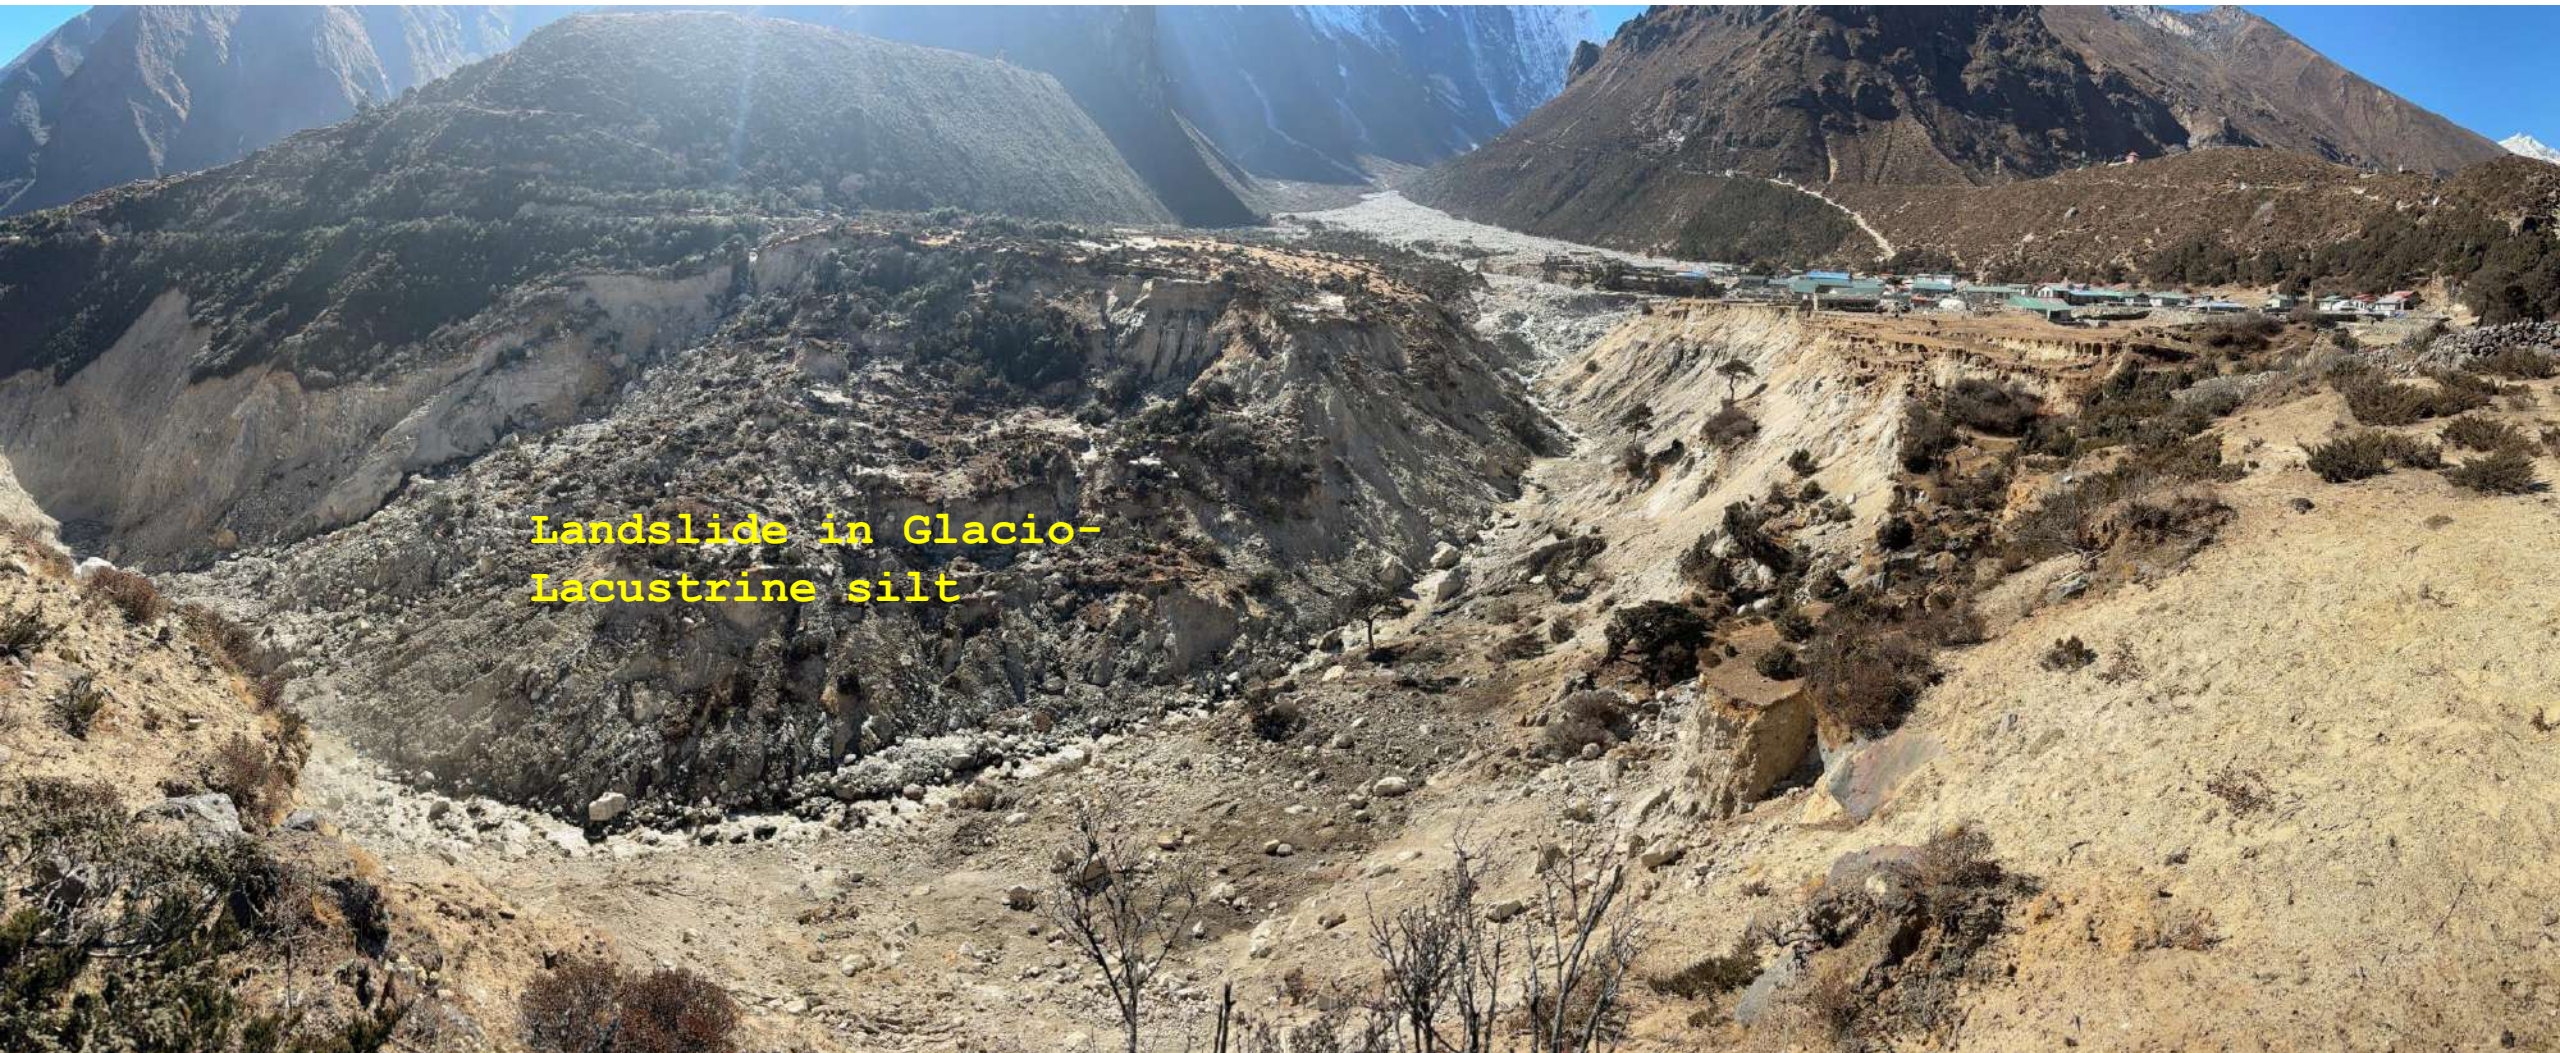
Landslide in Glacio-
Lacustrine silt

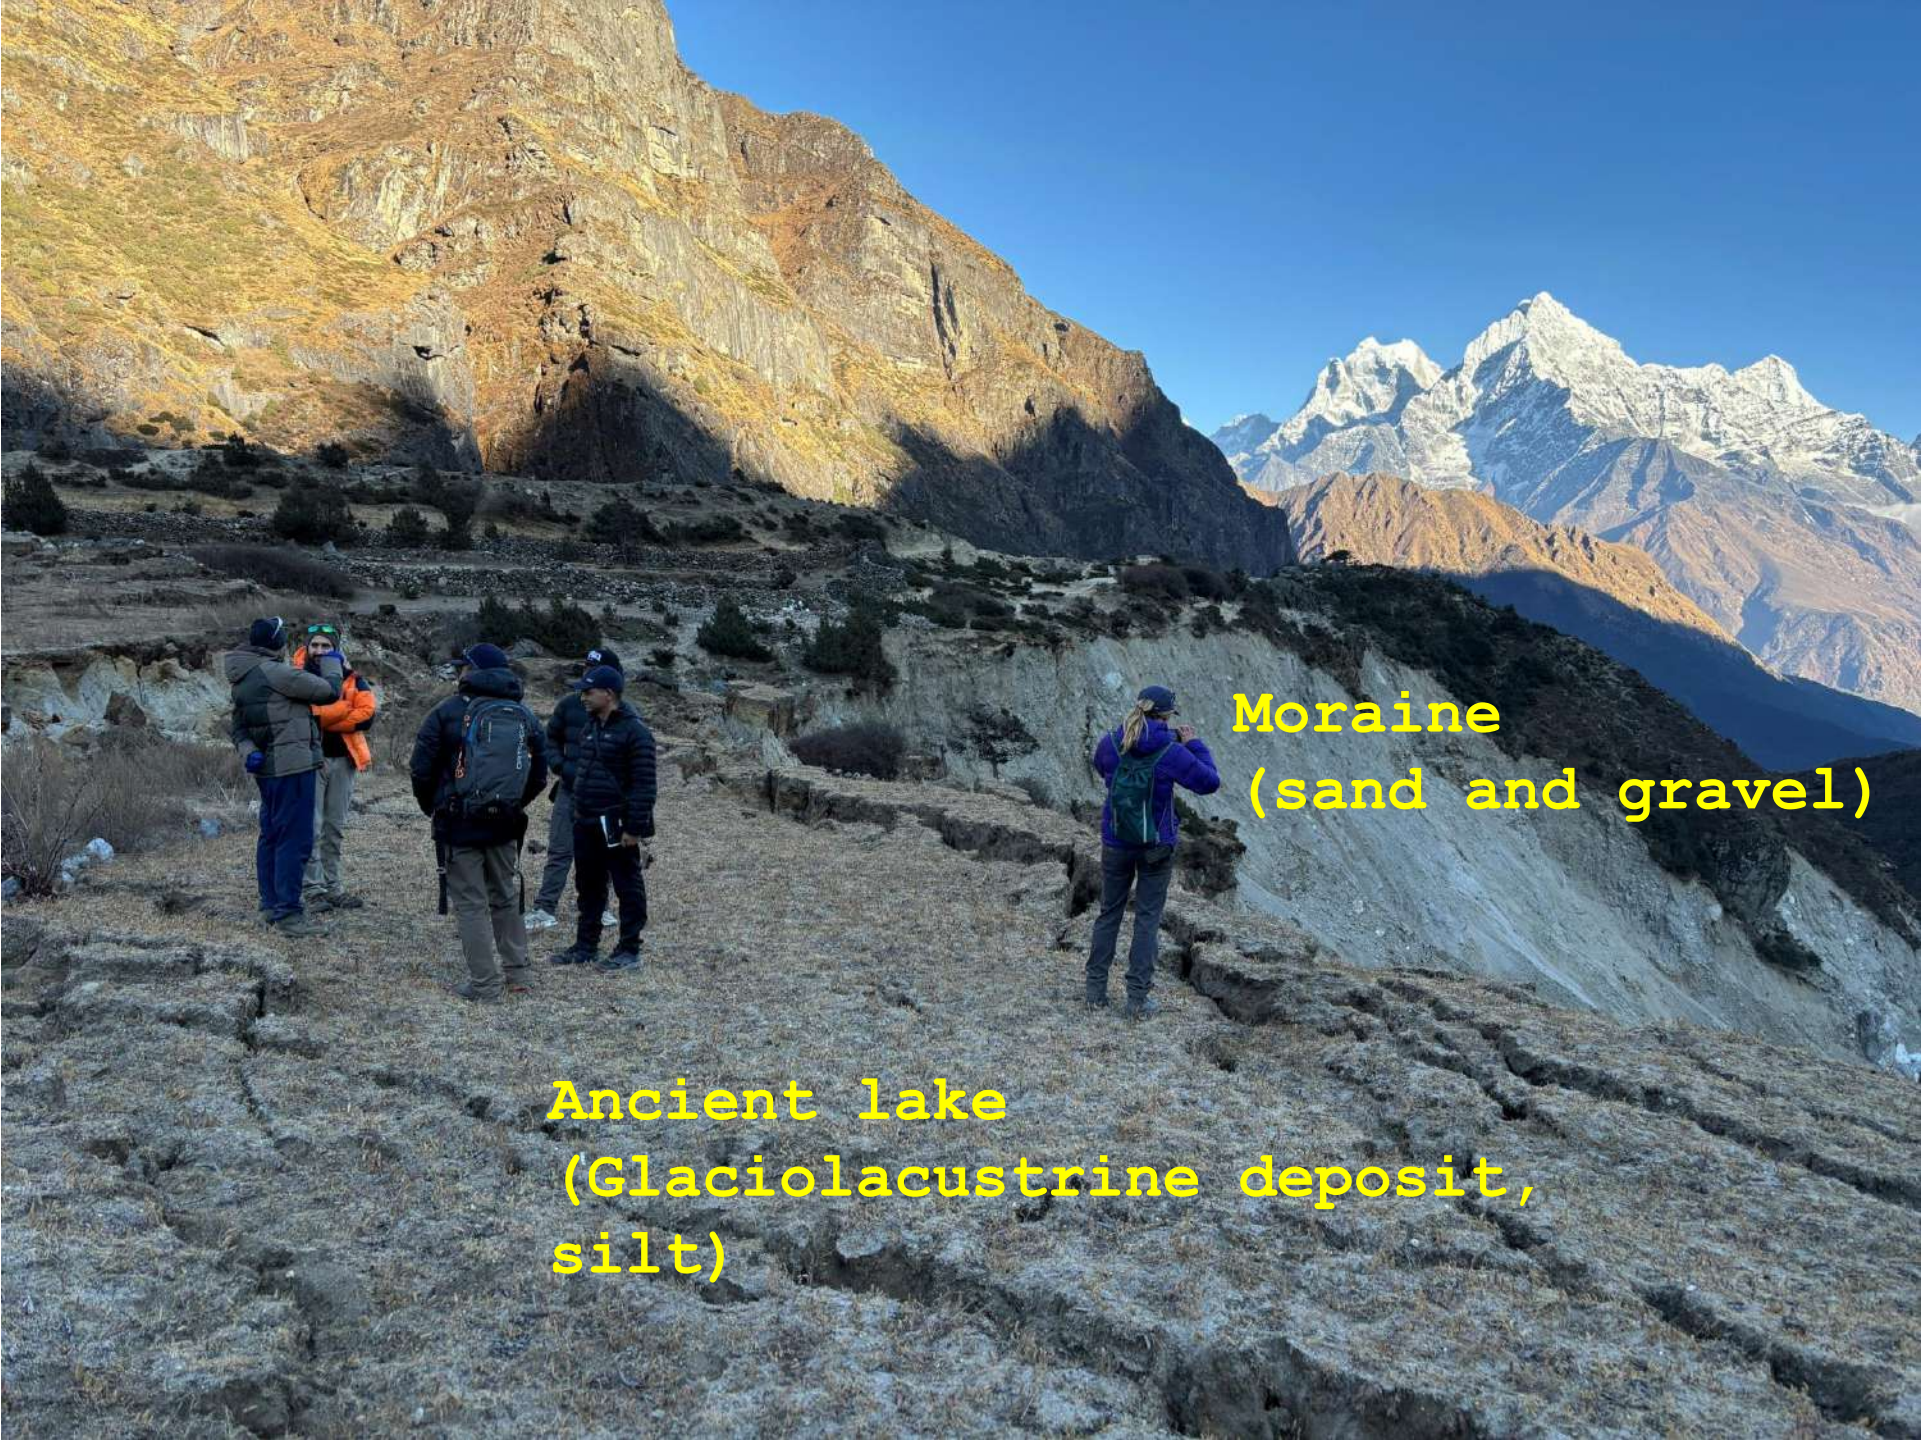
Moraine
(sand and gravel)

Ancient lake
(Glaciolacustrine deposit,
silt)

After ~3.5 months

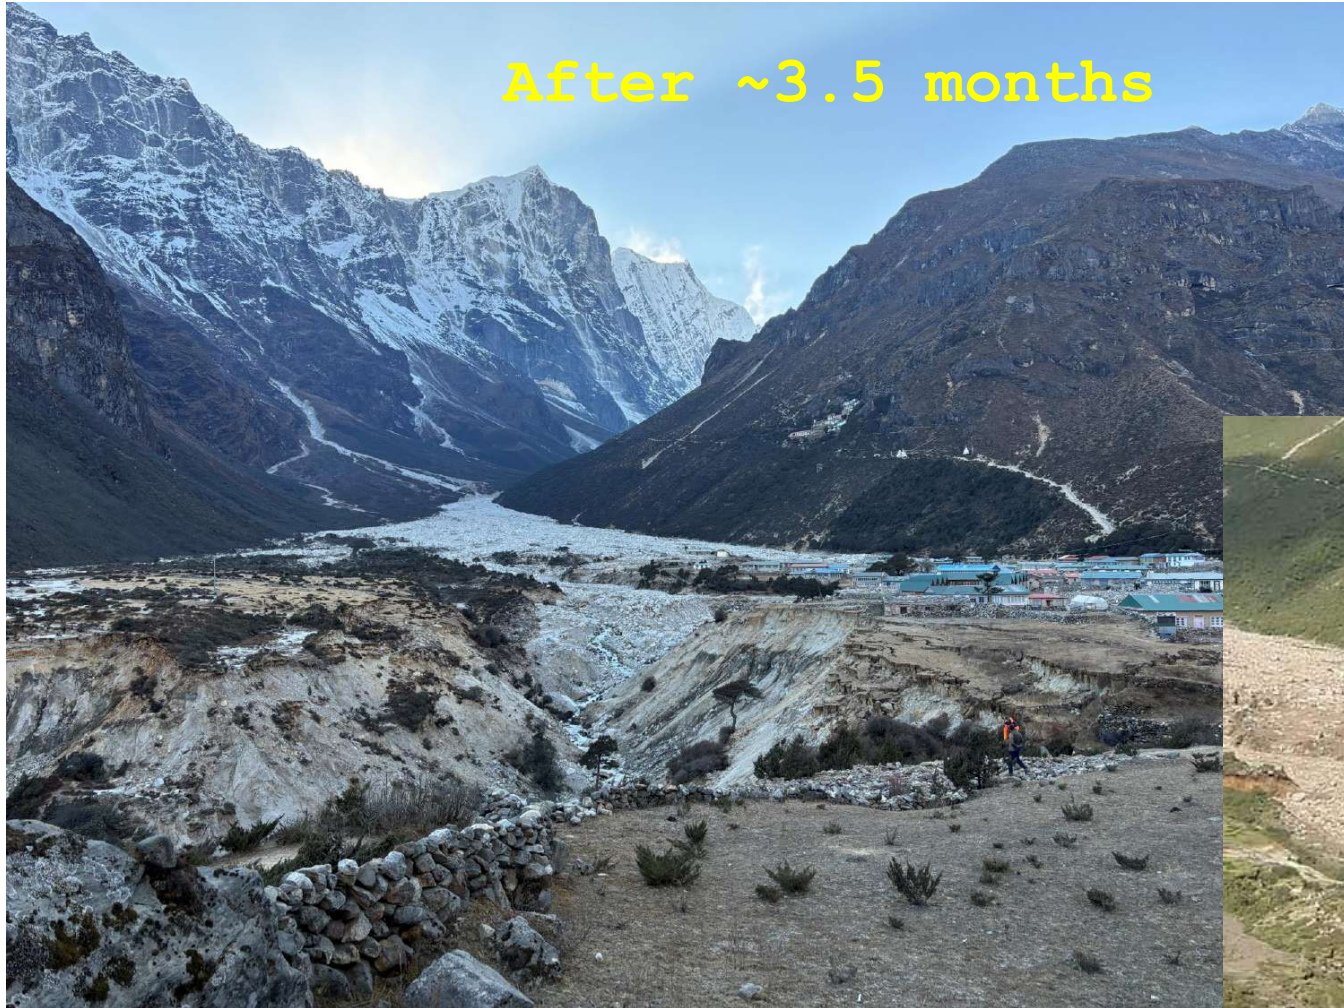
- No tension cracks were observed immediately after the event
- Significantly large rainfall occurred in a month of the event

Ground settlement/tension cracks related to landslide

- Ancient glacial lake filled with silt
- Significant erosion of channel during the GLOF – channel cut downwards
- Slopes destabilized
- Deep-seated, retrogressing landslides
- Tension cracks and settlement at surface

- Plan for retrogression and settlement
- Monitor tension cracks and ground movement to understand rate of change
- Avoid introducing water to surface
- Relocate buildings off of landslide

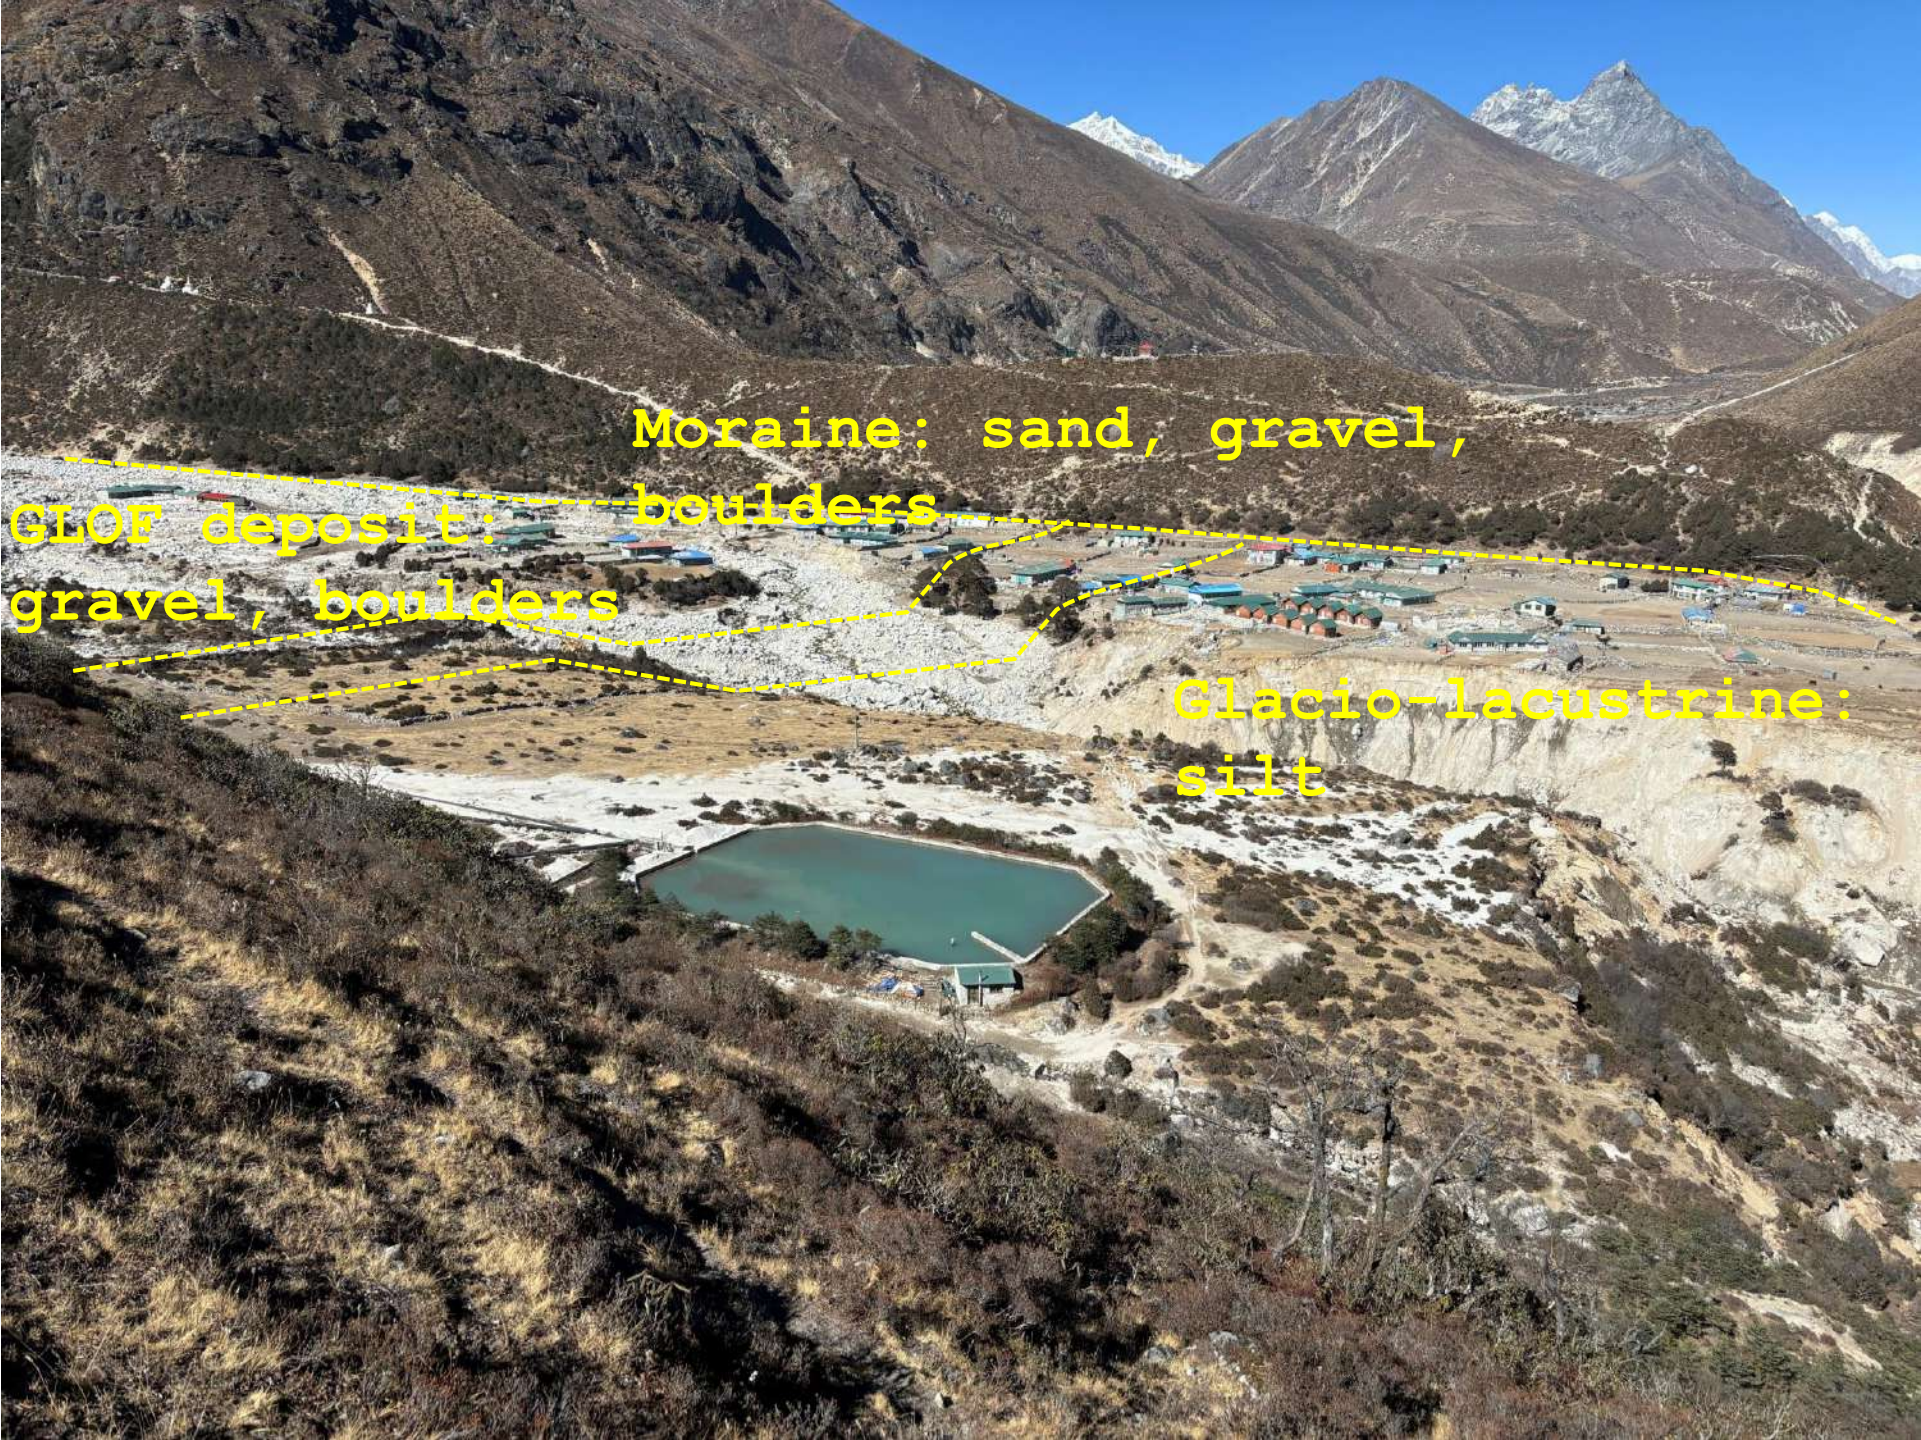
Moraine: sand, gravel,
boulders
GLOF deposit:
gravel, boulders

Glacio-lacustrine:
silt

GLOF and landslide damage at hydropower head works

- Deep-seated, retrogressing landslides encroach on head pond
- Intake damaged by GLOF debris impact and erosion

- Monitor landslide tension cracks
- Make plans for relocating the head pond
- Relocate intake and desander to toe of moraine to minimize exposure to GLOFs
- Move head pond if landslide continues to encroach on headpond

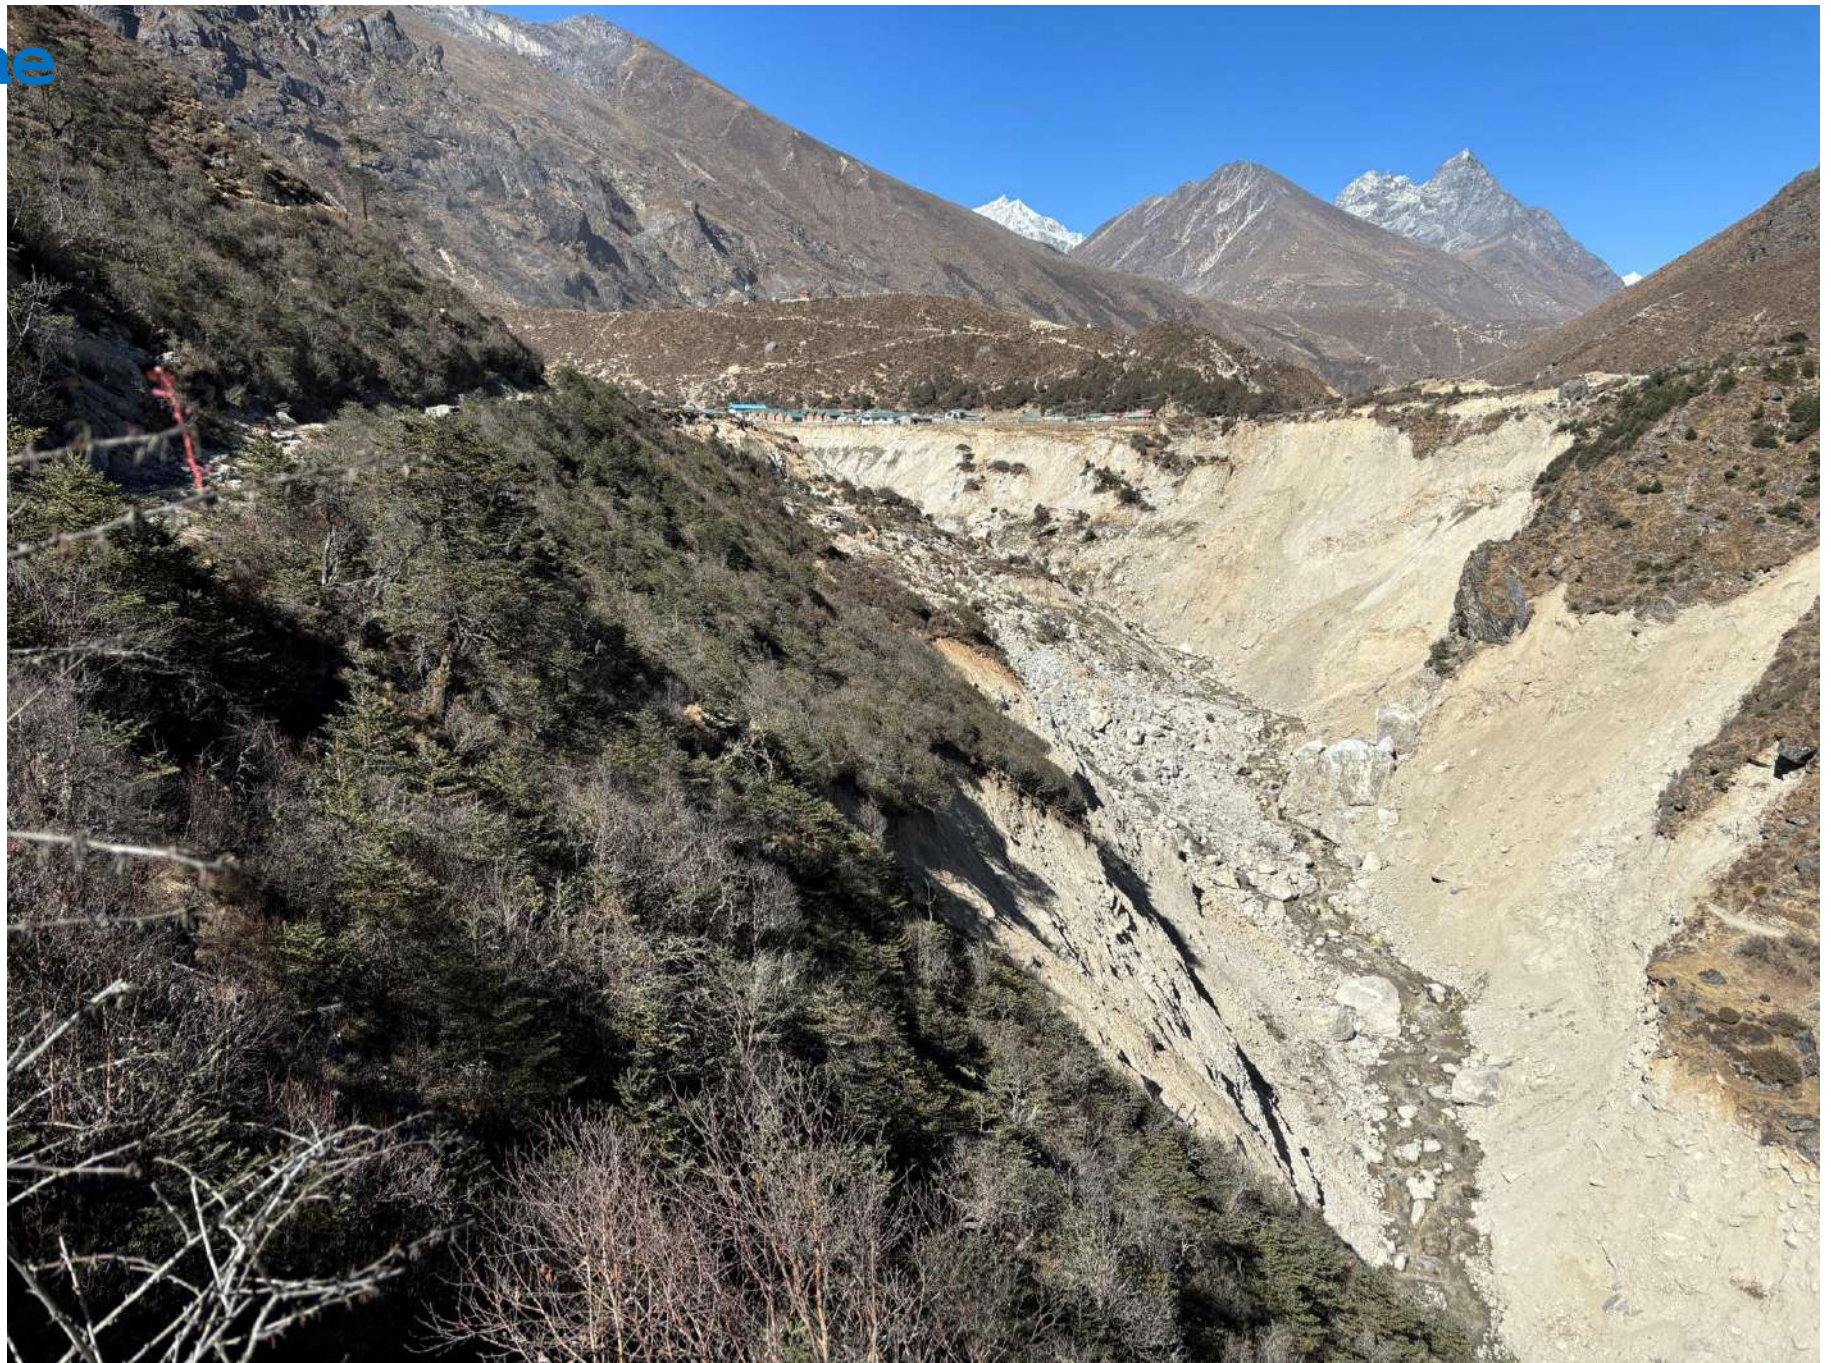
D/S of
Thame
Need to
monitor these
landslides

Landslides below penstock

- Shallow, steep landslides in coarse moraine have potential to undermine the penstock

- Monitor changes in the landslide to recognize encroachment on the penstock
- Develop plans to locally stabilize penstock or to move the penstock into the slope

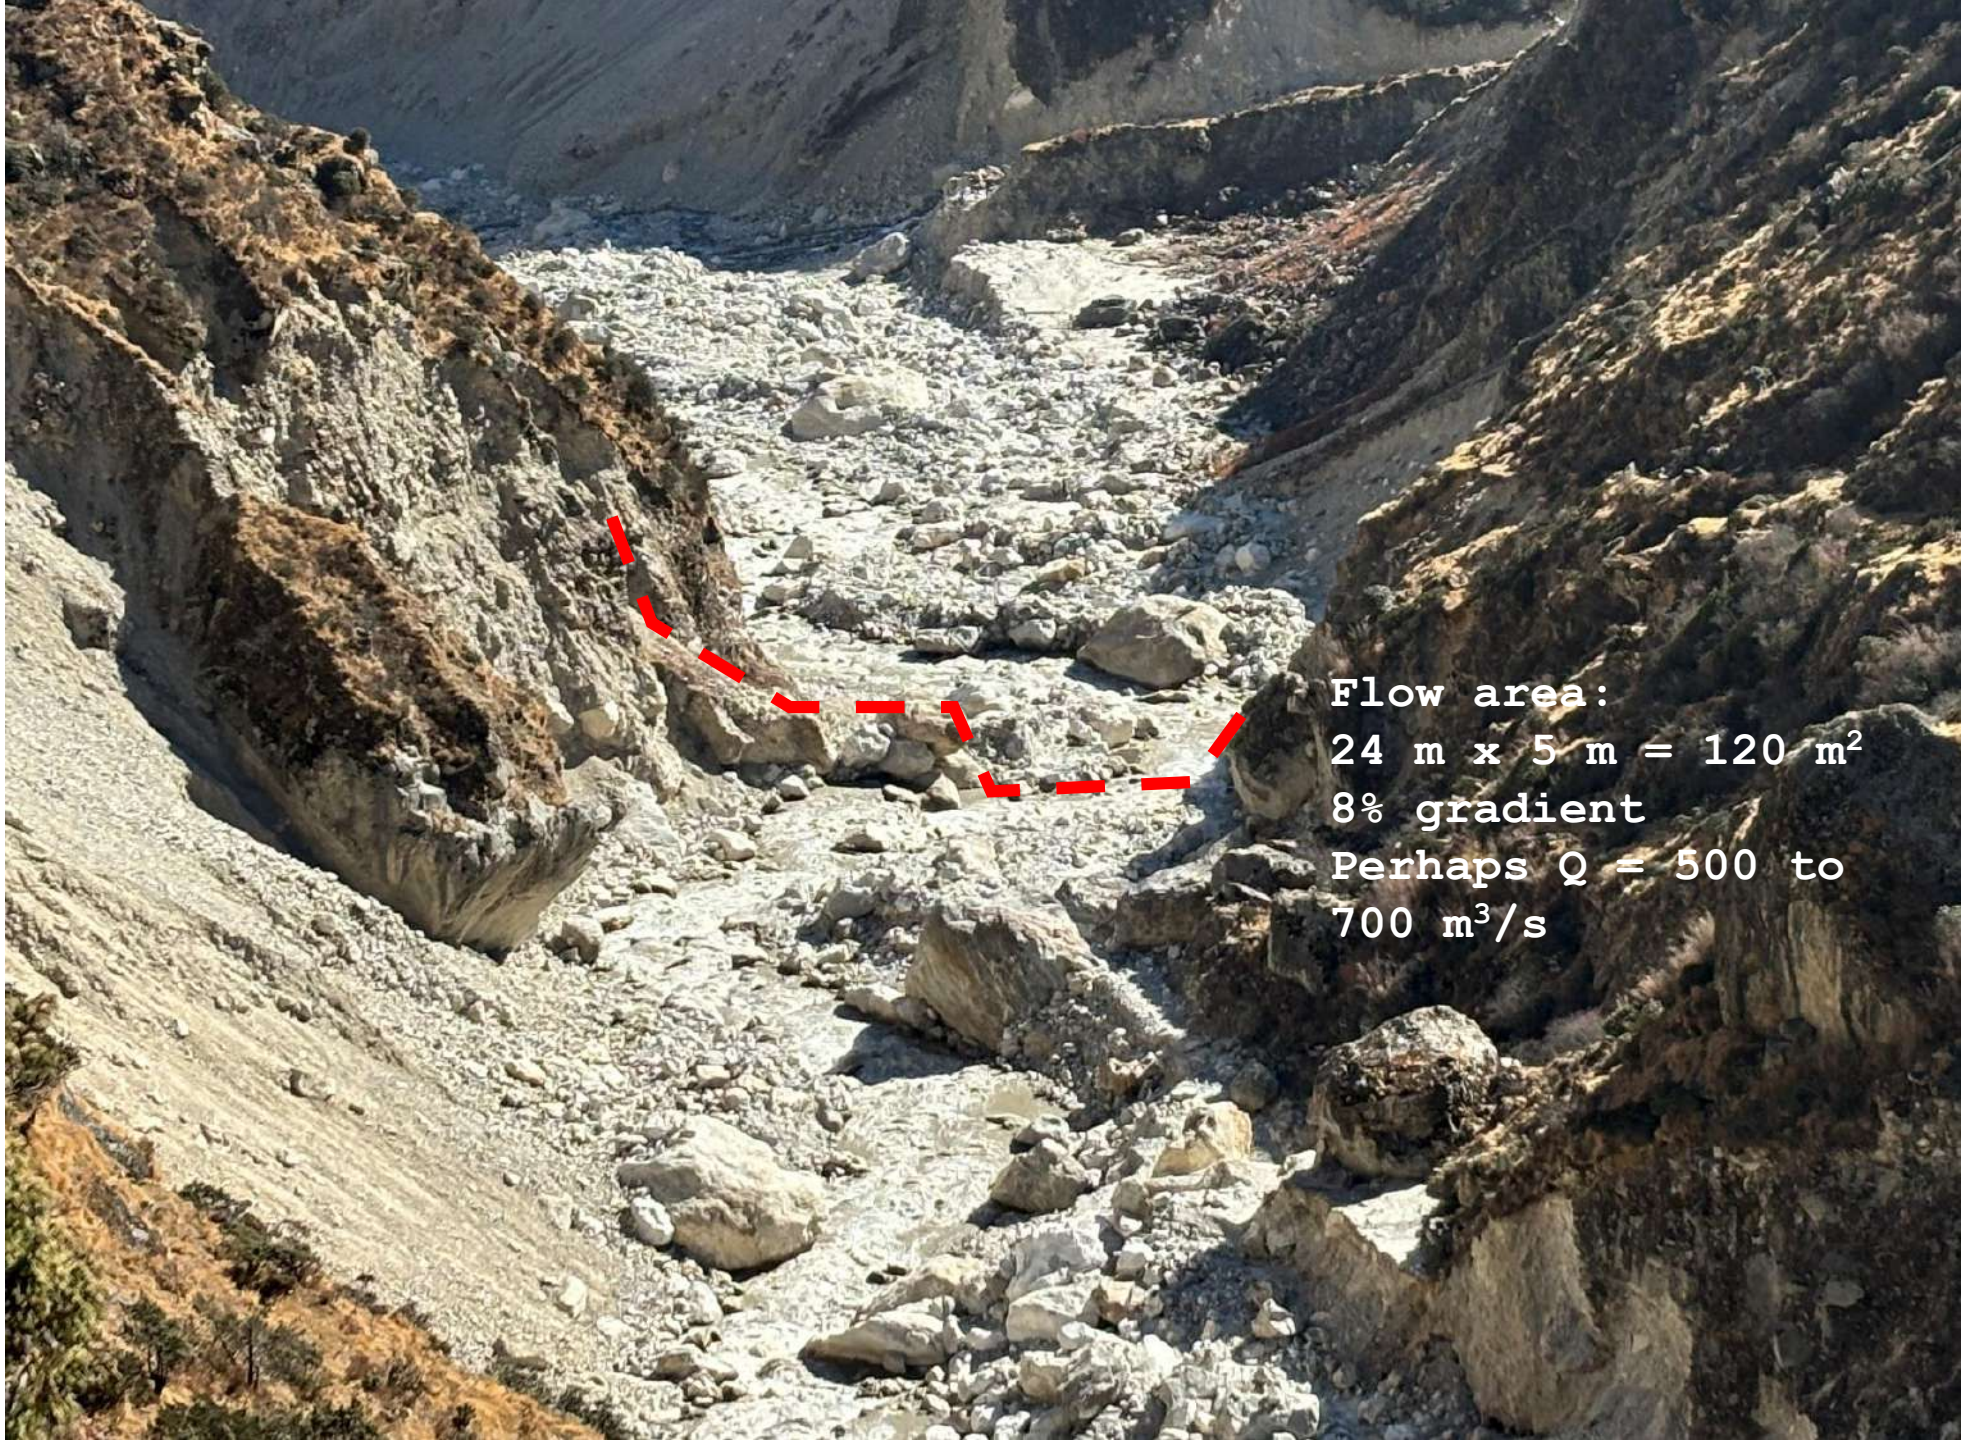
Flow area:
24 m x 5 m = 120 m²
8% gradient
Perhaps Q = 500 to
700 m³/s
