Effect of water level fluctuation on gabion revetment

Kochi University Master Student
Geotechnical Engineering Lab.
Motoharu Uchida

Objective of our research

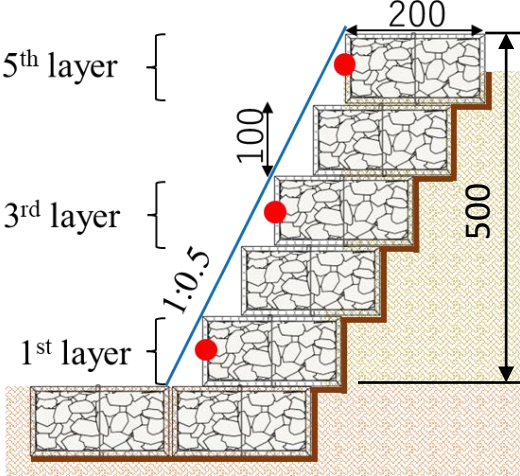
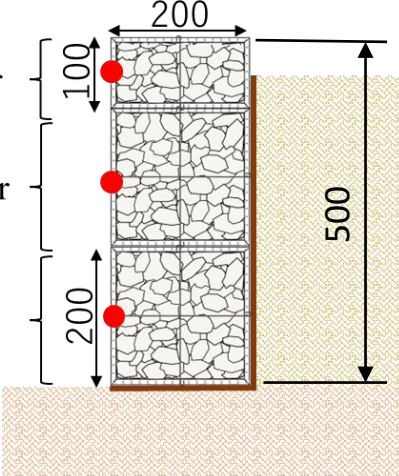
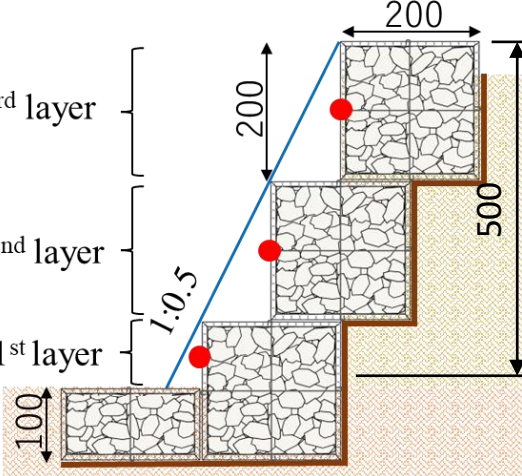
Case1: Slope type	Case2: Straight type	Case3: Mix type (with geotextile)

<p>Simulation in the common form used in Japan.</p>	<p>Simulation of gabions confirmed to be damaged in Nepal. Not performed root penetration and root fixing.</p>	<p>Simulation of gabions constructed by JICA. The cubic basket frames are stacked on a slope.</p>

Comparing the effects of water level fluctuations based on different **gabion structure design**.

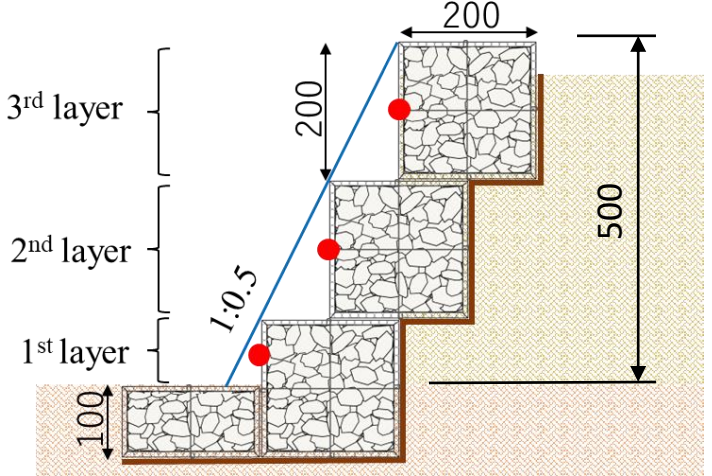
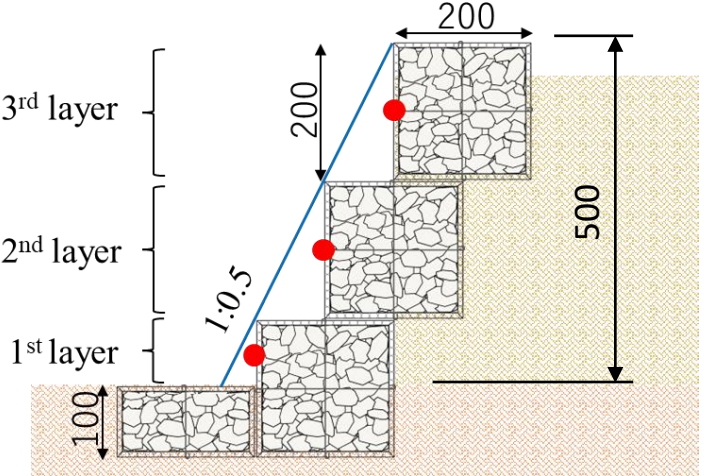
Case3: Mix type (with geotextile)	Case4: Mix type (without geotextile)

<p>Installing geotextile between the gabion and the backside.</p>	<p>Geotextile is not installed between the gabion and the backside.</p>

Comparing the effects of the presence and absence of **geotextiles** on gabion revetments on water level fluctuations

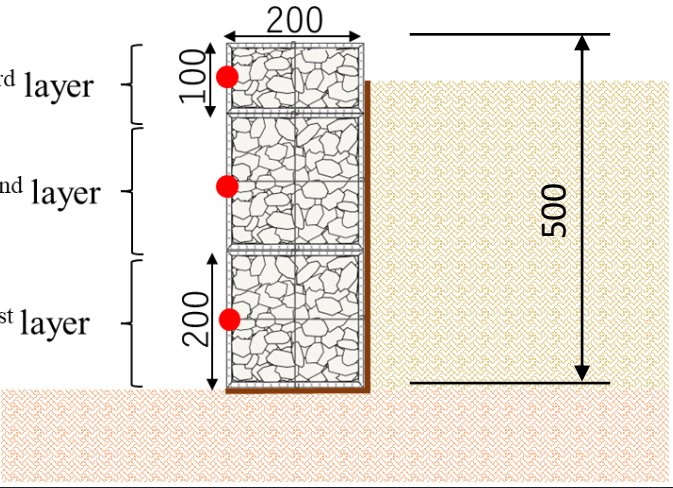
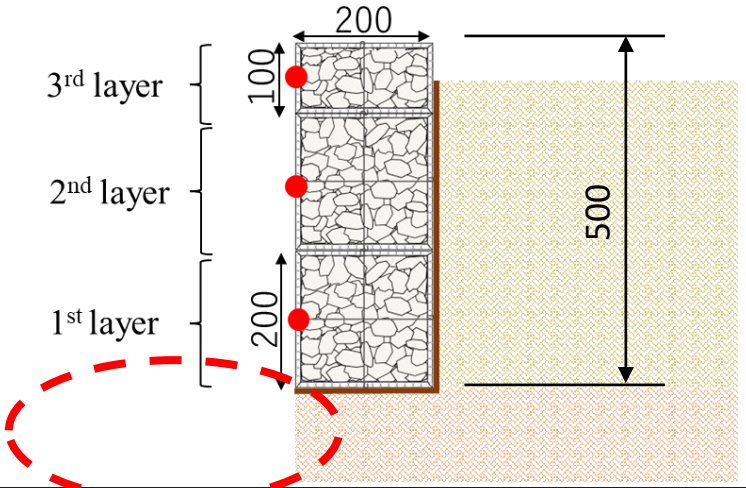
Case2: Straight type	Case5: Straight type (erosion Ver)

<p>Simulation of gabions confirmed to be damaged in Nepal.</p>	<p>Anticipating erosion of the foundation ground. The front side of the foundation ground in Case 2 was removed.</p>

Considering the effects of **erosion** due to water level fluctuations.

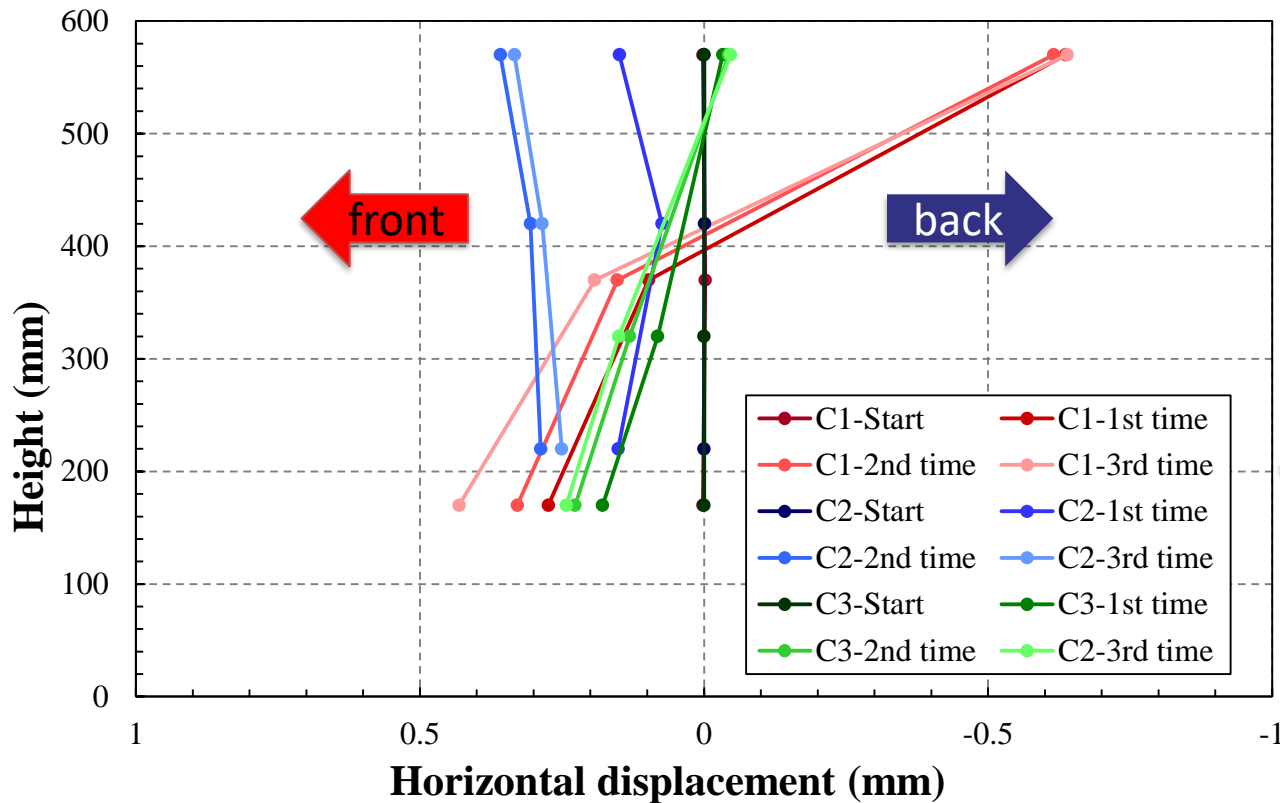
Comparison of horizontal displacement

At points other than those in the Straight and Mix types, the top layer indicated front side displacement due to an increase in earth pressure.

- Slope type and Mix type are displaced to **the backside** during the first water level change, but there is almost no displacement during the second and third times.
- Background experienced saturation, leading to subsidence due to water infiltration. As a result, gabion leaned **backside**.
- However, When the background stabilizes, it is suggested that there are no further displacement.

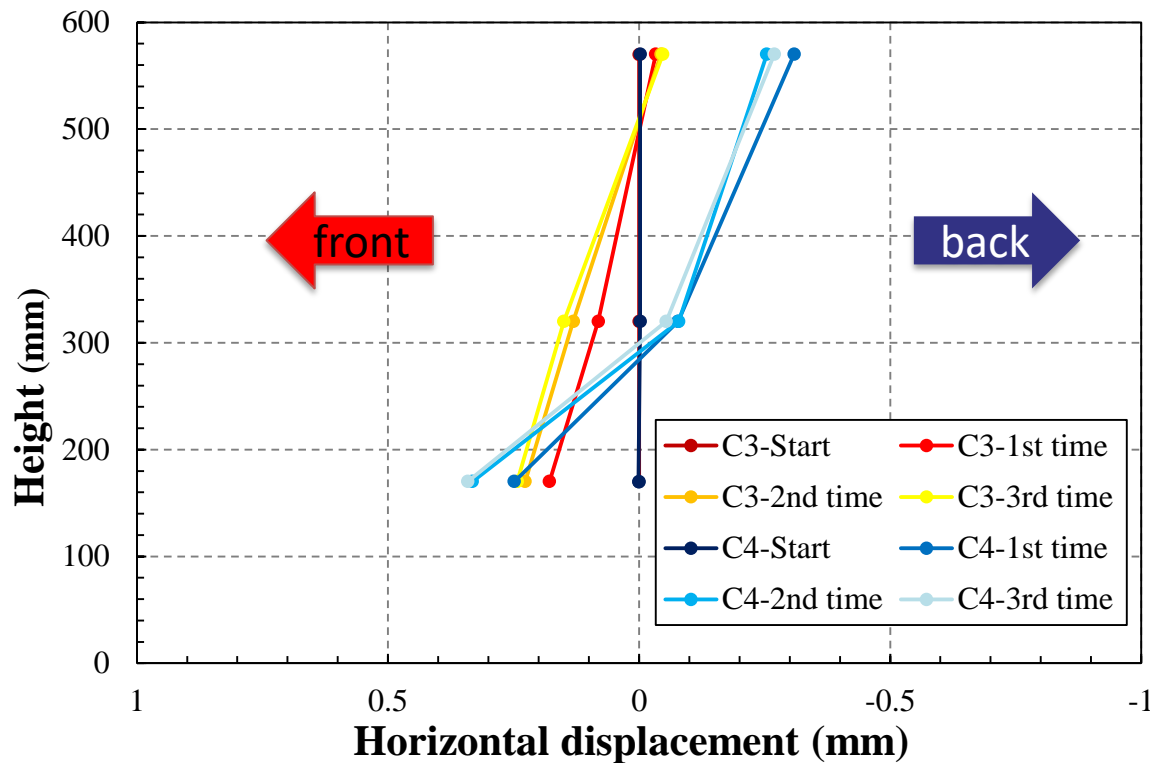
Comparison of horizontal displacement

Case 3: Mix type with geotextile

Case 4: Mix type without geotextile

- Similar trends were shown, but over all the displacement was smaller than in geotextile.
- In geotextile, the second layer shows a **front side displacement**, whereas without it, it shows a **back side displacement**.

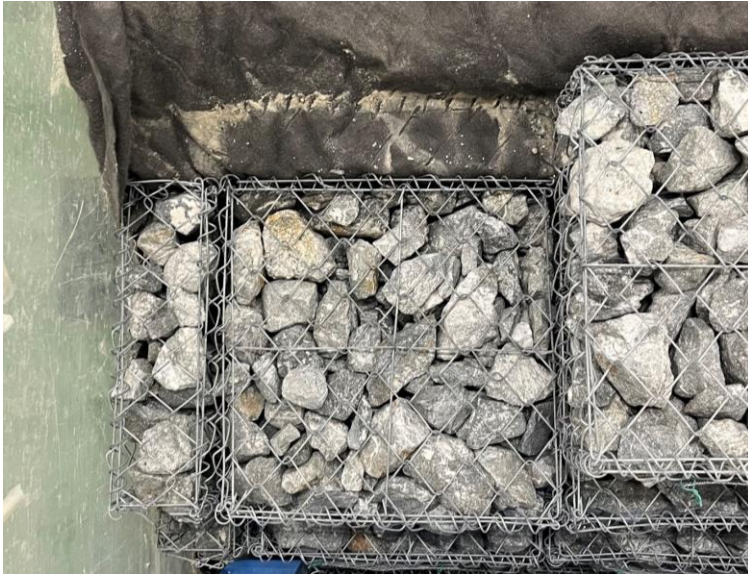
In geotextile

- Without geotextile, outflow of ground material was confirmed.
 - The back ground became destabilized due to missing background materials, it leaned on **back side direction**.

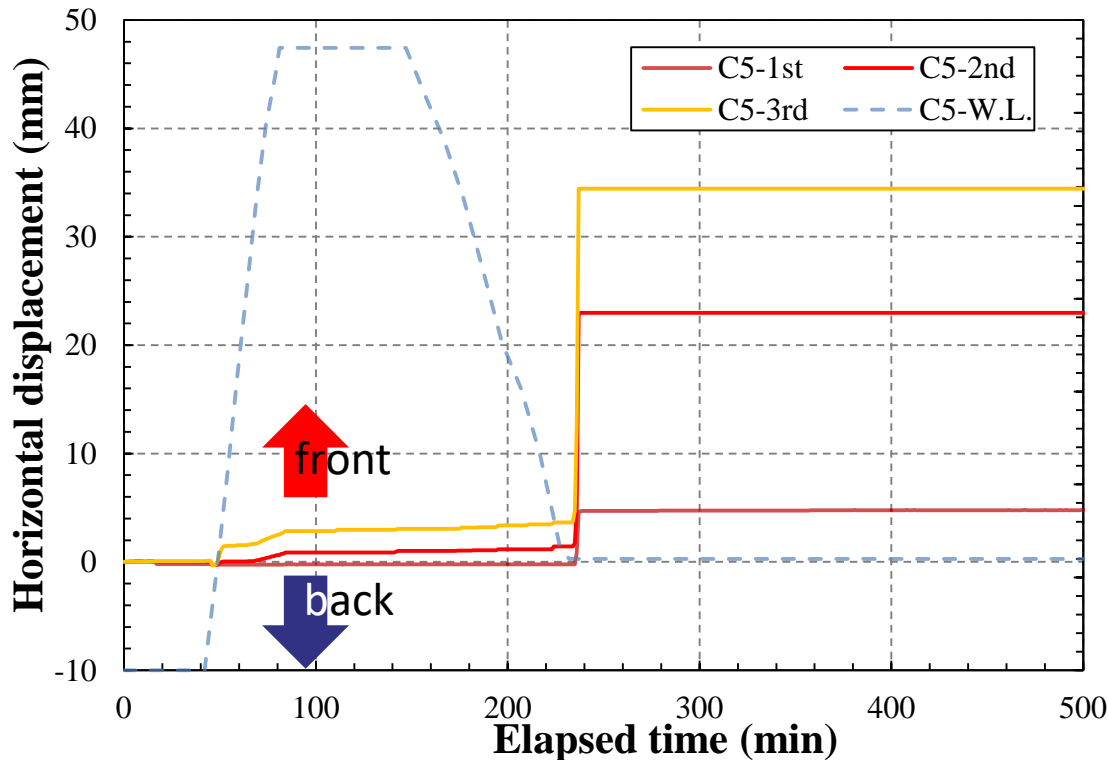
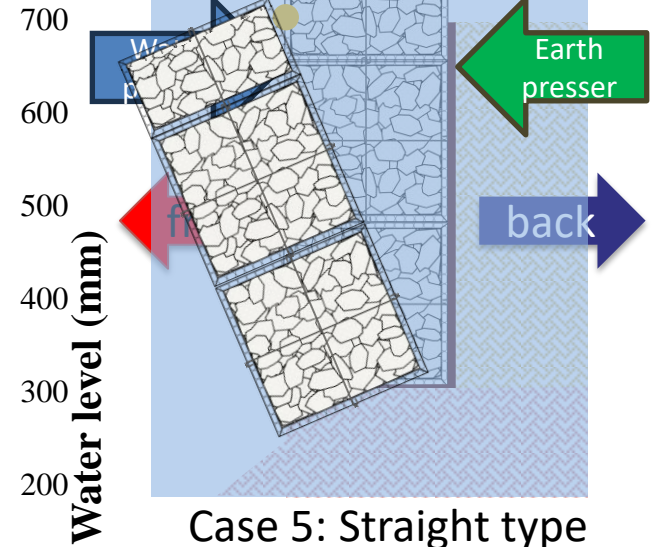
Temporal changes

Case 5: Straight type (erosion Ver)

- Displaced in **front side direction** due to the collapse of the foundation ground when the water level started rising.
- the water level reached the foundation ground level, gabion revetment completely collapsed.

- It was suggested that erosion of the foundation ground in front of the gabion could lead to additional erosion caused by the weight of the revetment.
- Although gabion revetments have excellent tenacity that follows the ground, it has been suggested that it may displace rapidly if the allowable amount of deformation is exceeded.
